An integrated remote sensing-GIS approach for the analysis of an open pit in the Carrara marble district, Italy: Slope stability assessment through kinematic and numerical methods

1 An integrated remote sensing-GIS approach for the analysis of an open
2 pit in the Carrara marble district, Italy: slope stability assessment
3 through kinematic and numerical methods
4

5 Authors: Francioni, M. (a); Salvini, R. (b); Stead, D. (a); Giovannini, R. (b); Riccucci, S. (b); Vanneschi,
6 C. (b); Gulli, D. (c).
7

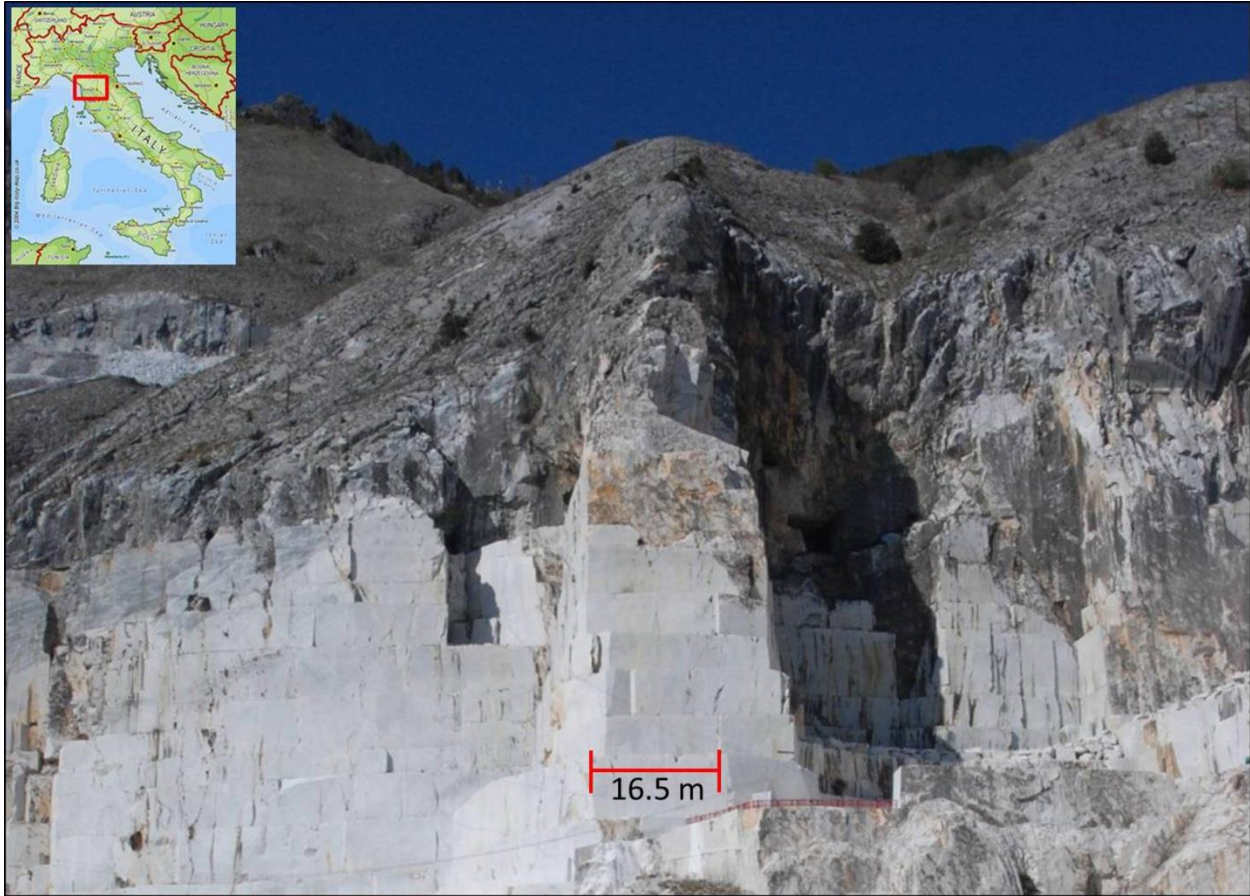
Figure 1. Perspective view of the study area: Lorano open pit walls characterized by the rock buttress shape (the scale is indicative only); inset map shows the location of the study area.

The Lorano open pit is located in the normal limb of the “Pianza Anticline”, between the “Carrara syncline” in the South-West, and the “Vallini syncline” in the North-East. The open pit is characterized by a rock buttress shape, a remnant of previous excavation activities left to ensure the stability of the rock slope to the rear. The marble buttress is accessible from three sides and is approximately 150 m high and between 30 to 50 m wide (Figure 1). In the study area there are two different types of marble outcrops: the “Ordinario marble”, that characterizes the buttress, and the “Venato marble” a natural outcrop occurring on the mountain slope above.

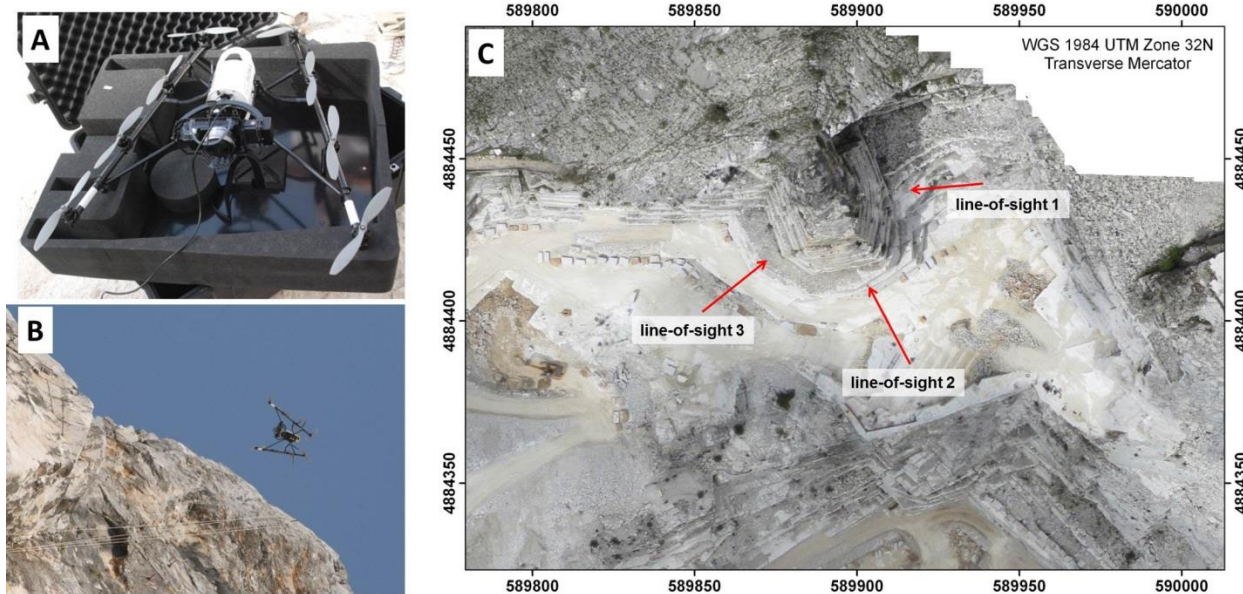
Figure 2. UAV survey: the Falcon 8 with stabilized digital camera Sony NEX-5N (A), vehicle during the flight on the right (B) and orthophoto of the open pit with the three different lines-of-sight used during the photogrammetric survey (C).

Based on a flight plan, photographs were automatically taken in order to cover the whole site acquiring vertical strips of images with a minimum 70% overlap and 30% sidelap. Auto-positioning of the UAV was controlled by the integrated inertial measurement unit. Due to the complex morphology of the area and the buttress shape, three different lines-of-sight were used during the photogrammetric survey. Figure 2C shows the orthophoto of the whole open pit and highlights the three different lines-of-sight.

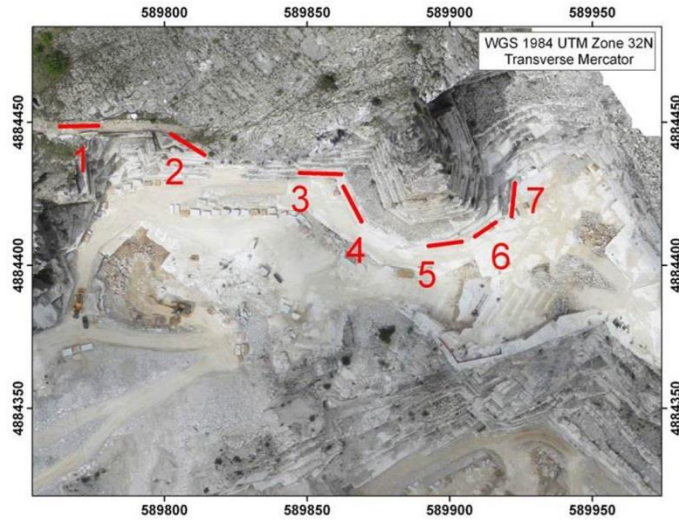
Figure 3. Orthophoto of the open pit with scan lines

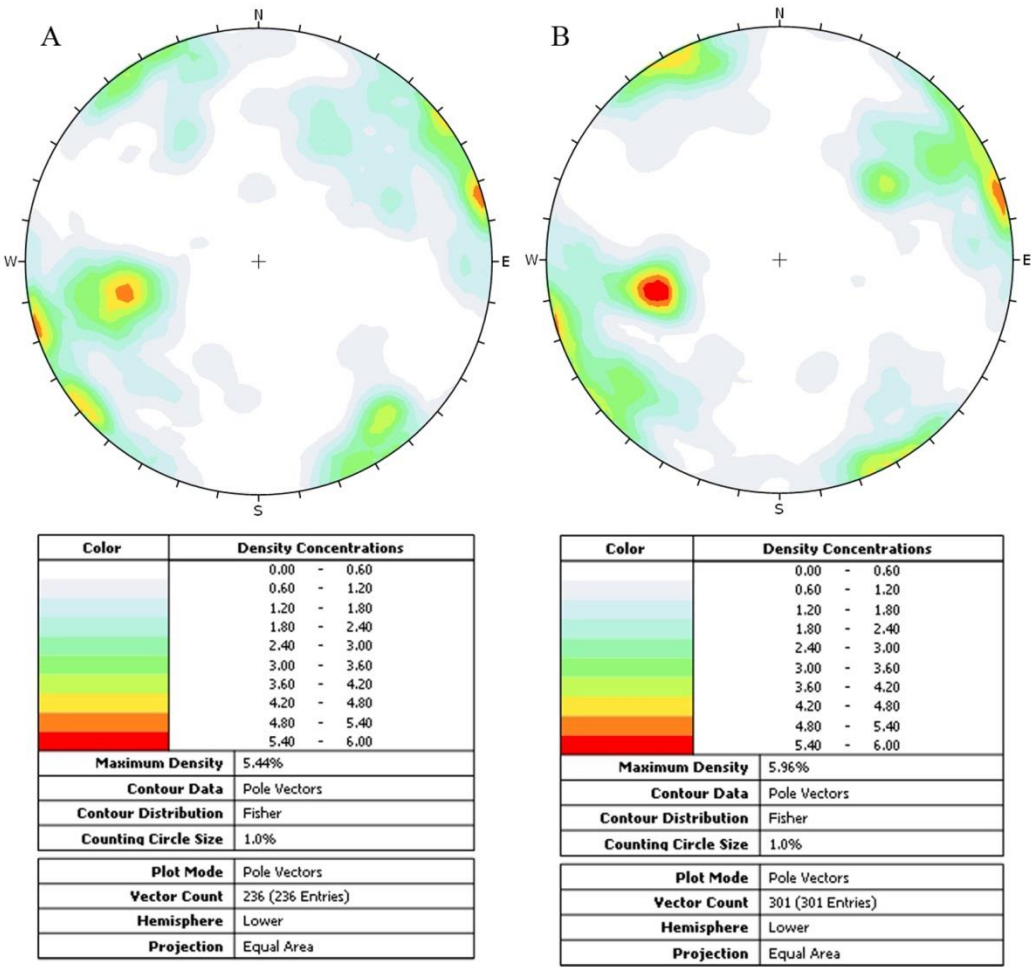
Figure 4. Stereographic representation of measurements obtained from DTP (A) and TLS (B).

The DTP approach provides a high level of data interpretability during the stereo-restitution but can be prone to human error. For this reason, the attitude of the discontinuity surfaces and slopes was also extracted from the TLS point clouds using the LeicaTM Cyclone software through a semi-automatic procedure. In practice, several points (at least three) representing the surface under investigation must be selected on the point cloud; the software automatically recreates the surface and determines the attitude of

its pole. Figure 4B shows the stereographic representation of the discontinuities measured on the slope using TLS.

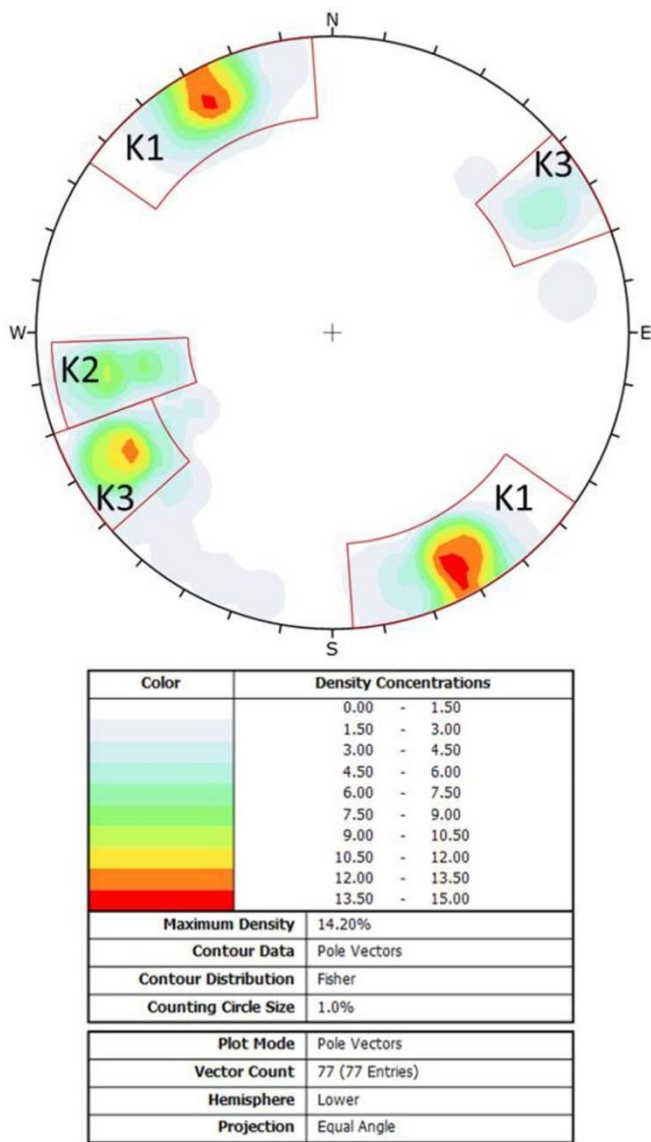
Figure 7. Stereographic representation of measurements determined from the conventional engineering geological survey.

Conventional engineering geological survey was necessary to assess the accuracy of the joint sets present at the toe of the slope and to physically and mechanically characterise the discontinuities according to the RMR method. Data obtained from this survey is provided in Figure 7 and Table 4; the results gained from

the rock mass rating show a good quality rock mass with an RMR value equal to 76. However, Figure 7 and Table 4 also show that the joint set distribution at the toe of the slope was slightly different to that determined from DTP and TLS. Therefore, data in Table 4 may not be fully representative of all the joint sets illustrated in Table 3 since they refer to different locations within the study area. In fact, GSI values also vary within engineered areas (i.e. open pit) compared to the natural rock outcrops (i.e. the above slope). For this reason and considering in detail the characteristics of the marble the GSI was estimated to vary between 50 and 60 in the natural slope and between 70 and 80 in the open pit face. This is probably due to the degree of weathering of the natural slope surface and to the fact that the joint spacing usually increases with depth.

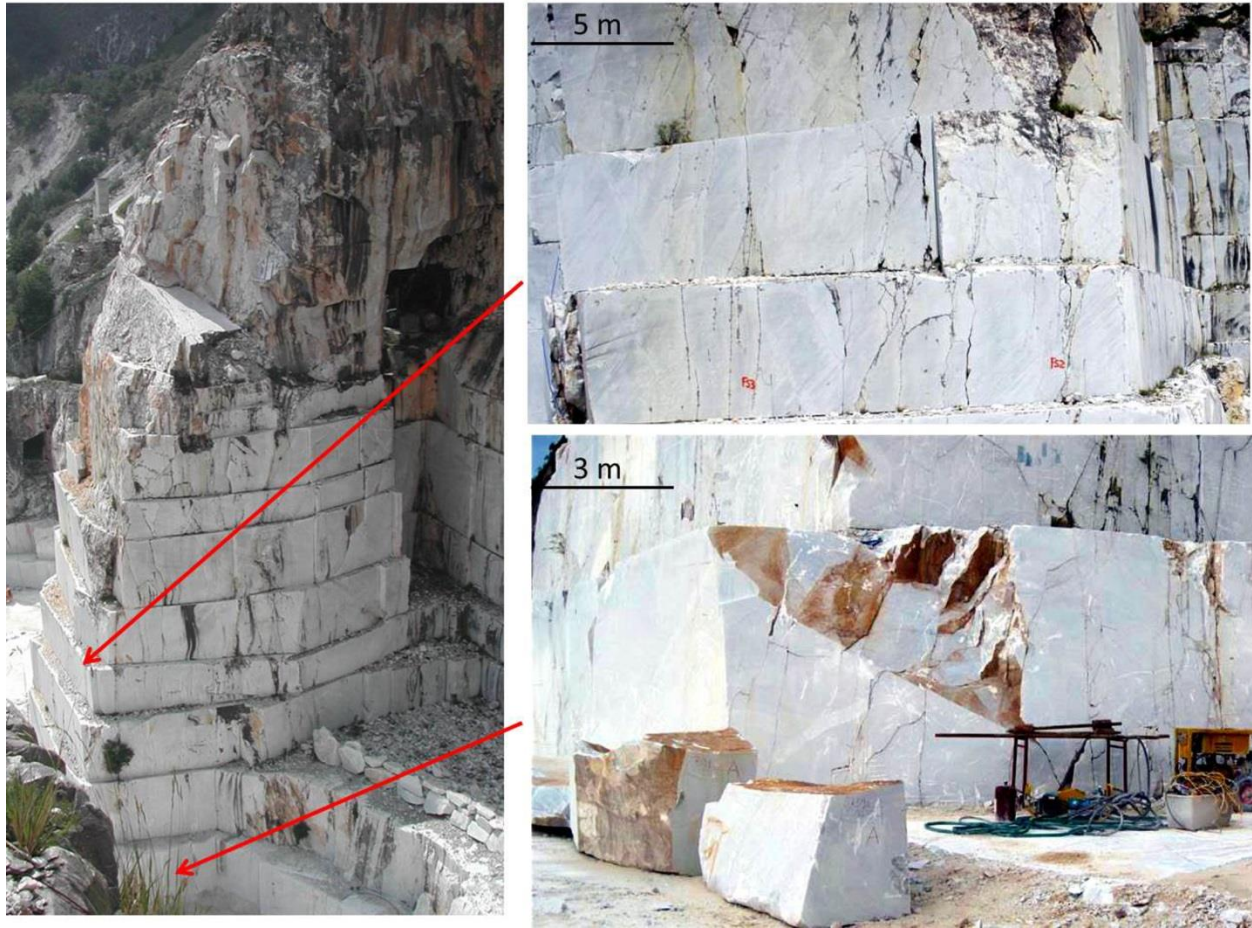
Figure 8. Stress-induced damage noted in the marble buttress during the engineering geological and photogrammetric surveys.

During both the remote sensing and engineering geological surveys, brittle (stress-induced) fractures were identified (Figure 8). It is possible to differentiate these structures from pre-existing discontinuities based on their irregular shape and the lower trace length. These characteristics can make their mapping sometimes challenging with a higher degree of uncertainty and, for this reason the measurements related to the stress-induced fractures were kept separate from those associated with joint sets.

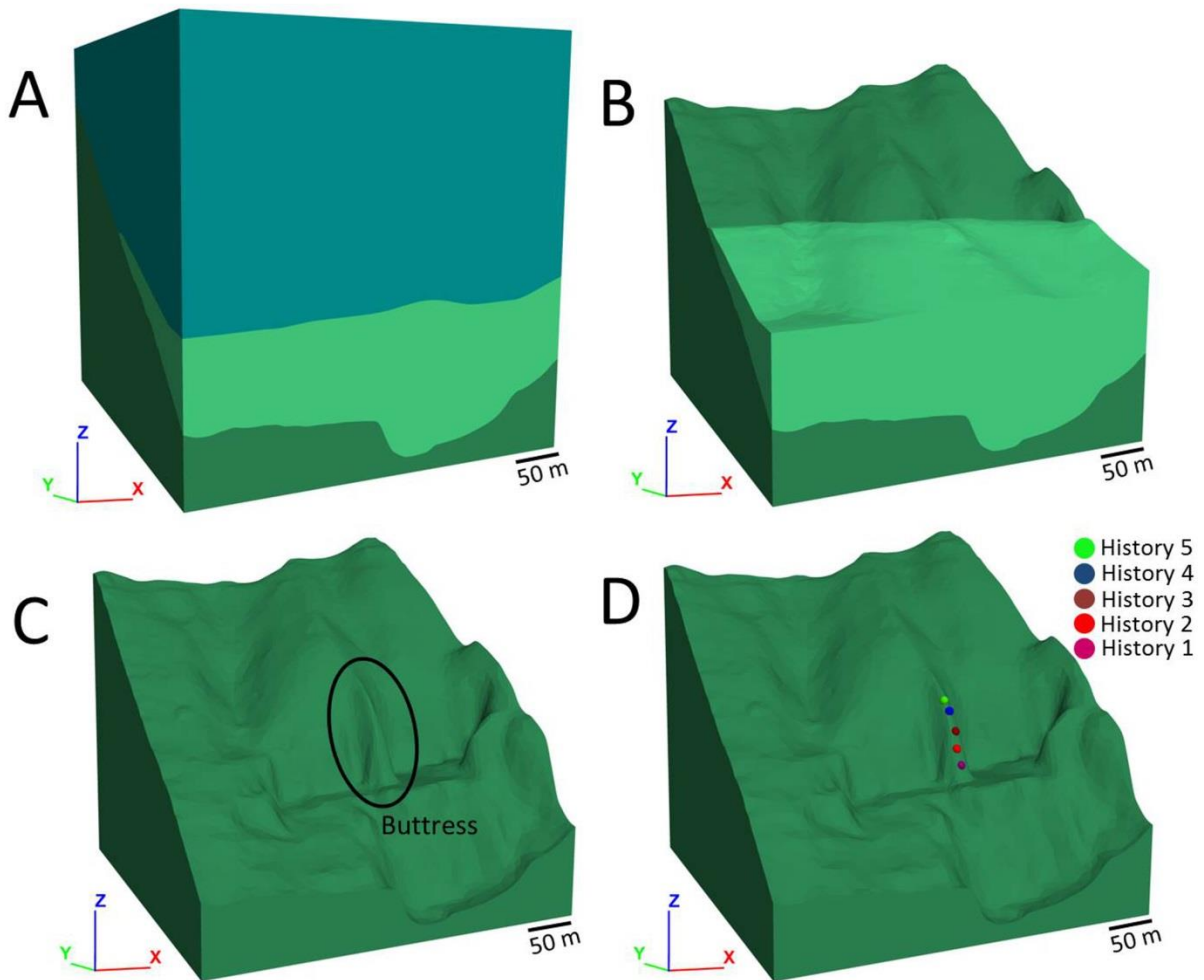
Figure 11. 3D model of the marble quarry and buttress created in Rhinoceros™ SR4 and Kubrix: Initial model (A), topography pre (B) and post (C) excavation and history points located in the buttress (D).

In this study, RhinocerosTM SR4 software [59] was used with the aim of creating a 3D model closely approximating the true geometry of the slope. TLS point clouds were processed to build the 3D model

and then exported into Kubrix software [49] to prepare for simulation using FLAC 3D [49]. Figure 11A-D shows the 3D model created by Rhinoceros™ SR4 and Kubrix. Figure 11A shows the initial geometry used to calculate the initial stress distribution. Figure 11B shows the reconstruction of the topography before the marble excavation. Figure 11C and D show the geometry of the buttress and the “history points” (points of interest) respectively; the latter were located at different elevations on the marble buttress and interrogated during the excavation progress.

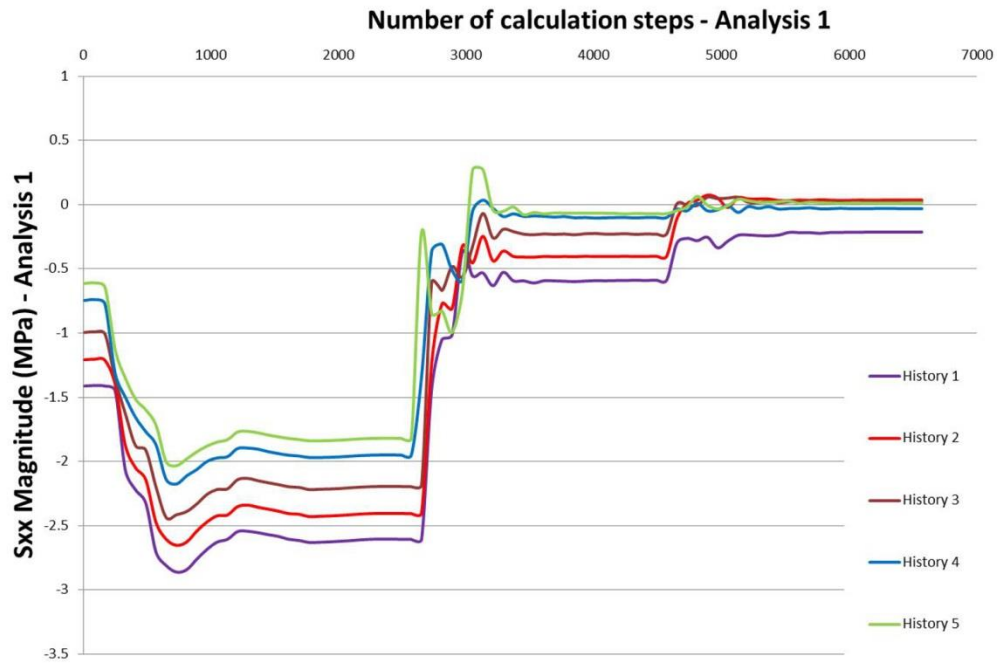
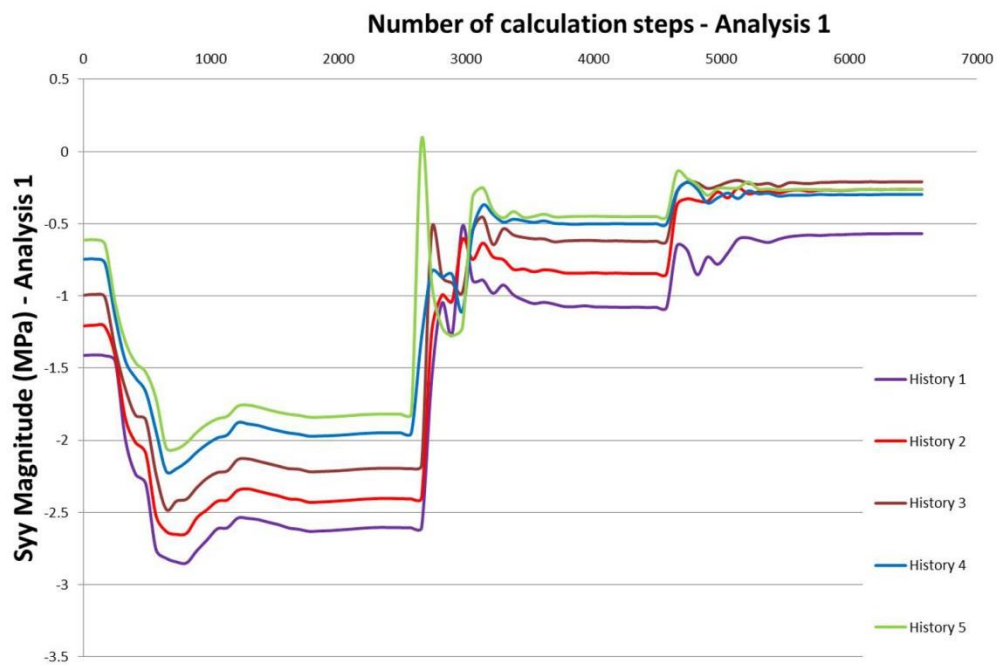
461 Figure 13. Analysis 1: simulated XX (top) and YY (bottom) stress magnitudes measured at the history
 462 points, $K_x = K_y = 0.4$. Location of history points 1 to 5 shown in Figure 11D.

The graphs show how the X-stresses (SXX) reach positive values at history points number 2, 3 and 5 (up to 0.04 MPa at the history point 2) and how they have very low negative values (compressive) at history points 1 and 4. Moreover, all the history points show that Y-stresses (SYY) are very low and close to positive values but that tensile stresses are not observed. It is important to note that, owing to the lack of field in-situ stress measurements these results assume an initial $K_x=K_y$ value of 0.4 and do not take into account probable tectonic in-situ stresses; the results consequently show relative stress changes with excavation only and not the true absolute values.

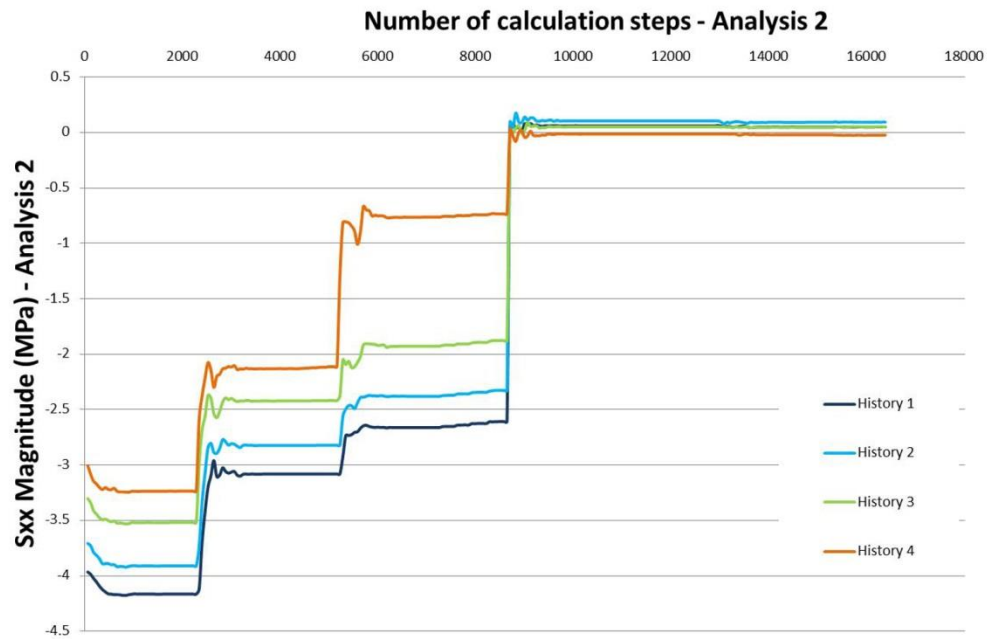
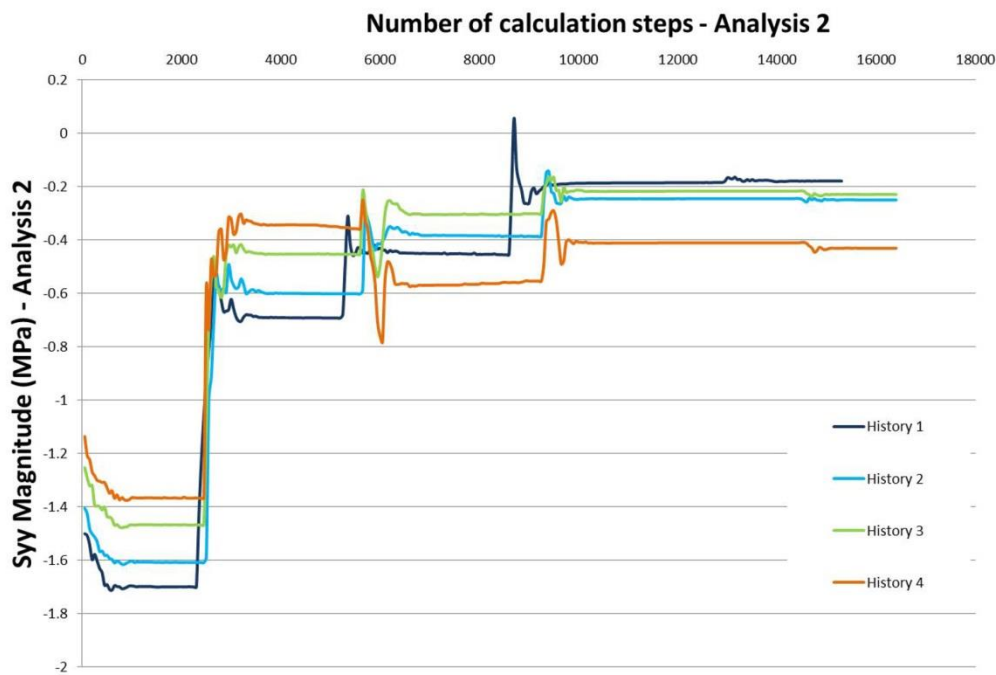
529 Figure 16. Analysis 2: simulated XX (top) and YY (bottom) stress magnitude measured at the history

530 points, $K_x = 0.6$ and $K_y = 0.4$. Location of history points 1 to 5 shown in Figure11D.

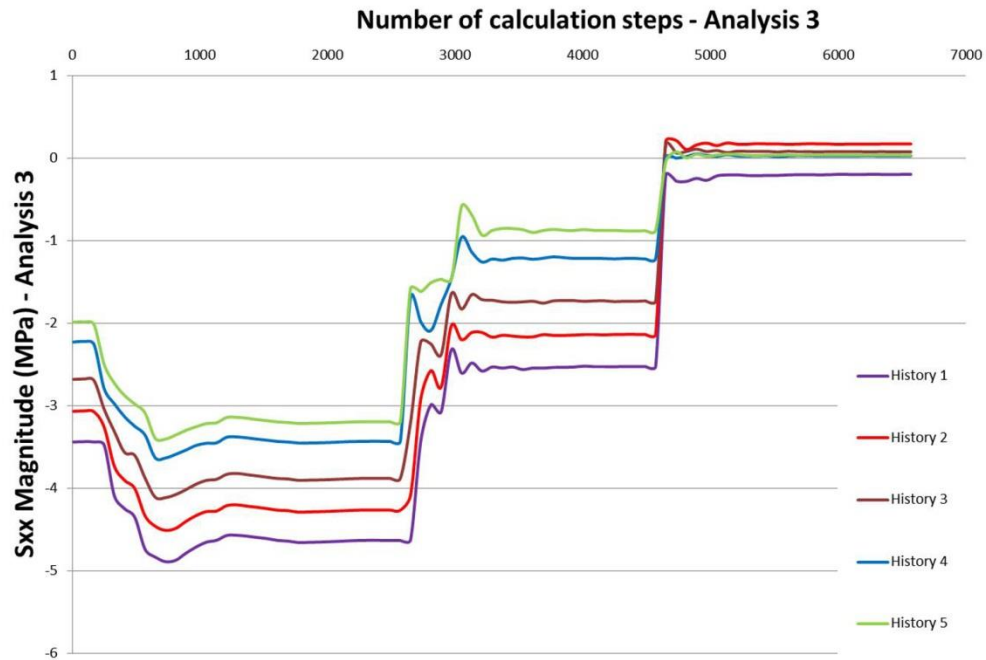
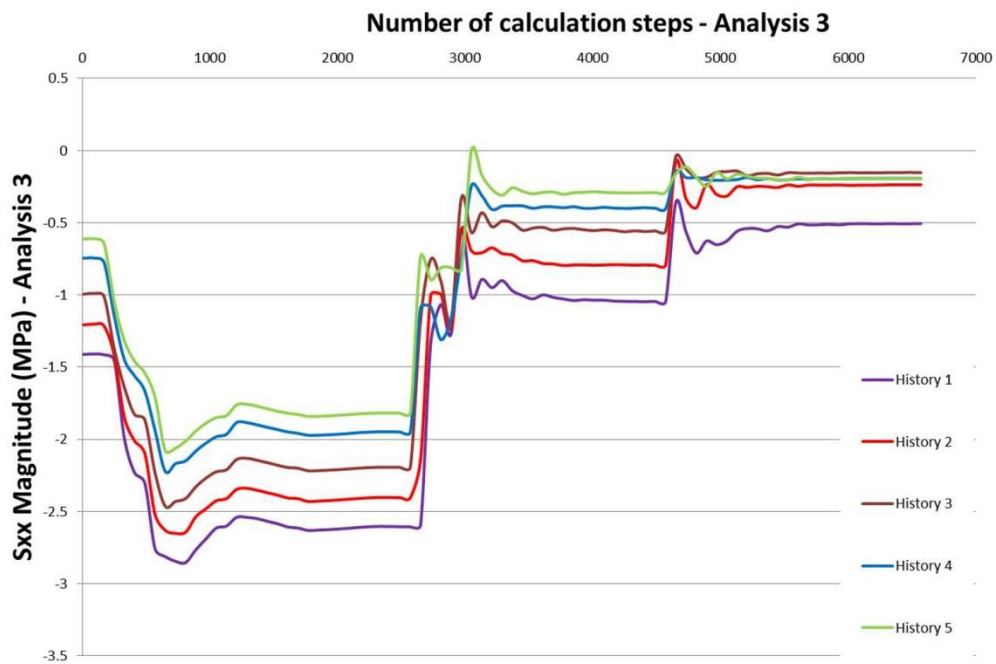
Figure 17. Analysis 3: simulated XX (top) and YY (bottom) stress magnitude measured at the history points, $K_x = 0.8$ and $K_y = 0.4$. Location of history points 1 to 5 shown in Figure11D.
