# Lethal trajectory: a case of fatal injury from an accidentally projected metal fragment<sup>☆</sup>

Giacomo Madeo<sup>☆</sup>

University of Siena, Italy

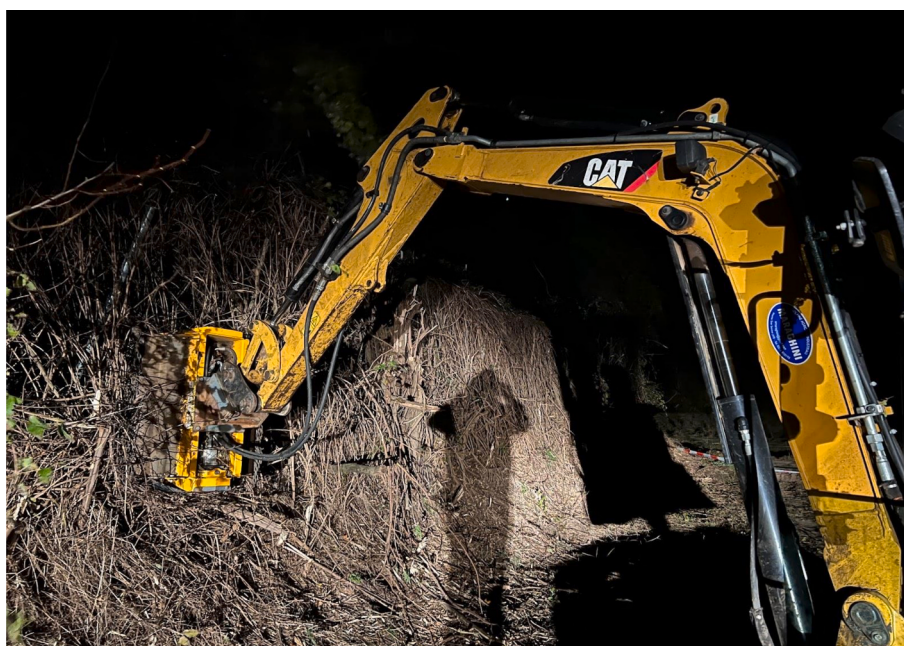
**Photo 1.** Brush-cutter arm touching the hedge, with a wire mesh fence located behind it.

The fatality occurred in open countryside. The scene inspection was carried out at 18:30, two hours after the discovery of the body, with the aid of artificial lighting. The body lay supine on the roadside at the edge of a field accessed through a wide ungated entrance. Inside the field, about 70 m away, there was a Caterpillar tracked excavator, oriented towards a hedge behind which stood a metal fence with anti-intrusion spikes. The excavator was equipped with a hedge-cutting arm with lateral chains. The arm was touching the hedge, approximately 1,5 m above the ground, positioned parallel to the driver's cab. The front windshield of the excavator was shattered, missing its lower left portion corresponding to the driver's seat; numerous glass fragments of various sizes were scattered both inside and around the machine (Photos 1–3).

The key factor triggering the injuring potential of the metallic fragment — later recovered from the seat — was the velocity imparted by the hedge-cutting mechanism. Contact with the metal fence spike caused detachment of the fragment, which became incandescent and was projected at high speed.

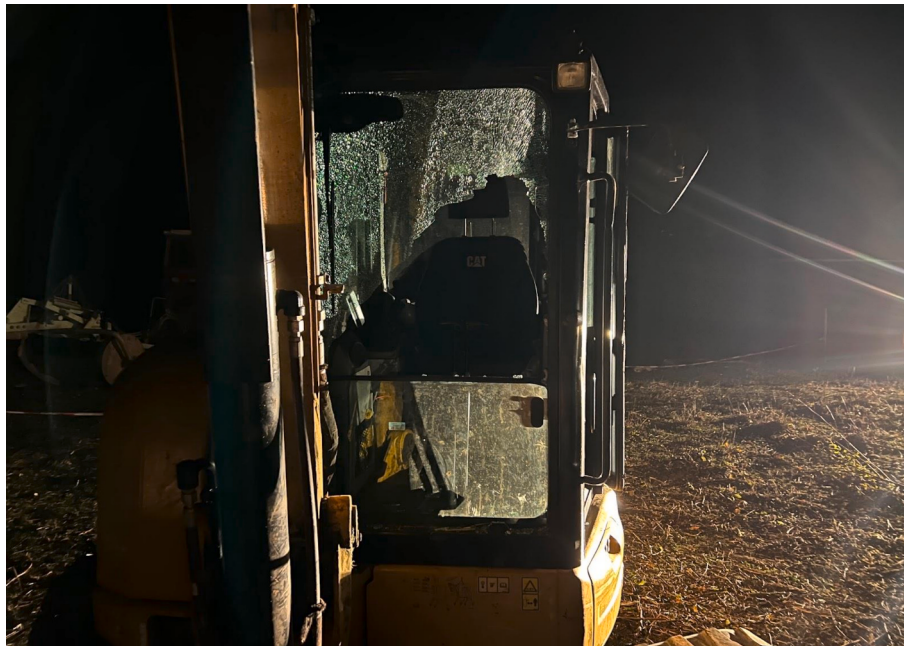
**Photo 2.** The front windshield was shattered and missing its lower-left portion.

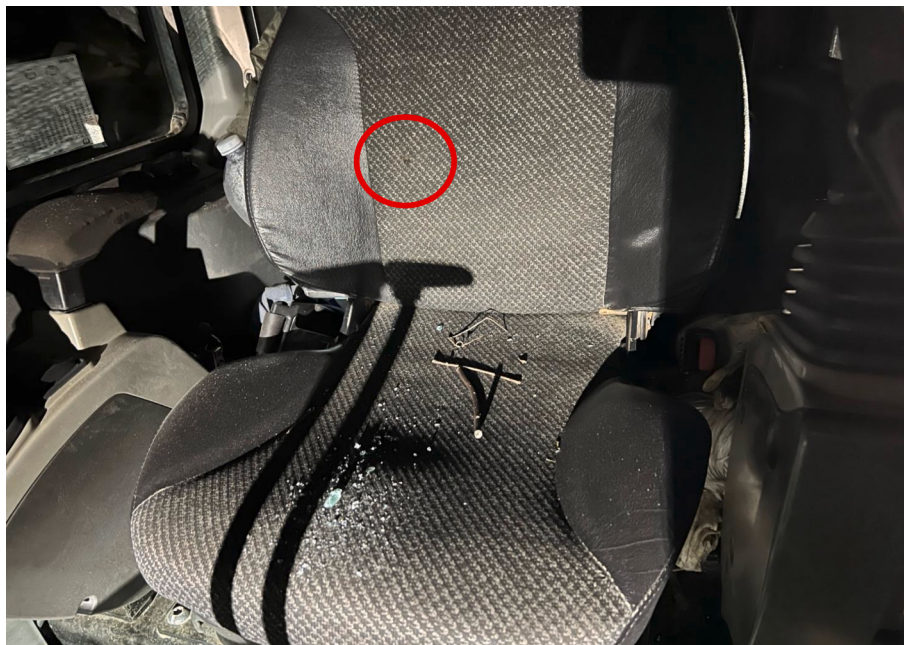
**Photo 3.** Metal fragment and glass fragments on the seat. On the upper left part of the backrest, a small hole in the fabric.

On the seat, multiple glass fragments of varying size and a cylindrical metallic fragment, grey-black in color, irregular in shape, 0,5 cm in diameter and 15 cm in length, were observed. On the lower third of the left side of the seatback, corresponding to the driver's position, there was a punctiform discontinuity (Photo 3).

man to seek help but leading to progressive deterioration and death within approximately twenty minutes. The metallic fragment found on the seat is fully compatible with the fatal projectile.

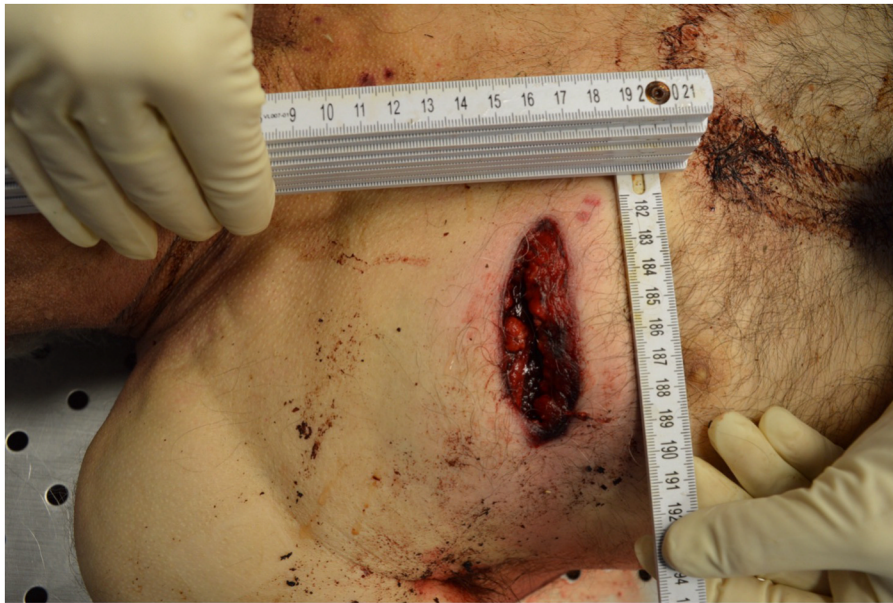
**Photo 4.** A discontinuity of the tissues was observed in the upper right pectoral region (entry wound).

On the face and neck, numerous excoriations and small discontinuities were noted, caused by the impact of windshield glass fragments. On the anterior chest, in the upper right pectoral region, there was a contused-lacerated wound with bruised margins and burn features. The wound was linear, transversely oriented, measuring 8 cm in length, with maximal diastasis of 2,5 cm; it extended into the underlying soft tissues with hemorrhage and exposure of deeper layers (Photo 4). On dorsal inspection, the back appeared diffusely smeared with soil and blood. On the lower third of the right side of the back, there was a 0,5 cm "C"-shaped wound, concavity facing downward, with blood extravasation (Photo 5).

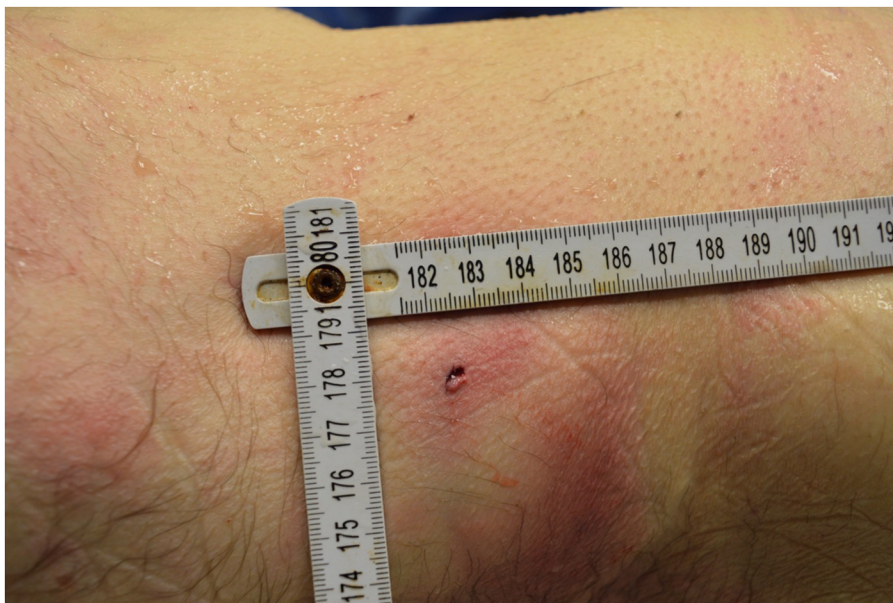
**Photo 5.** A discontinuity of the tissues was observed on the right lumbar region (exit wound); note the margin were everted.
