Use of a remotely piloted aircraft system for hazard assessment in a rocky mining area (Lucca, Italy)

Riccardo Salvini¹, Giovanni Mastrorocco¹, Giuseppe Esposito¹, Silvia Di Bartolo¹, John Coggan², and Claudio Vanneschi²

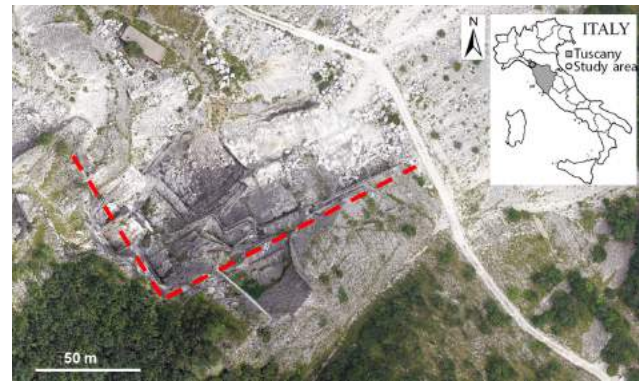
Figure 1. Plan view of the Piastrone open pit with indication of the two principal slope directions (dotted lines). Inset map shows the location of the study area.

The study area is located in the Apuan Alps marble district, in the province of Lucca (Tuscany, Italy; Fig. 1). The open pit or quarry, named Piastrone, is characterized by a V shape, with two principal slope directions oriented 50/90 and 323/90 (dip direction/dip). The bottom of the pit is located at 1180 m above sea level (m a.s.l.) and the top of the excavated rock face is at 1300 m a.s.l. The rock mass is characterized by different sets of discontinuities with persistence values that can vary from a few metres up to decametres.

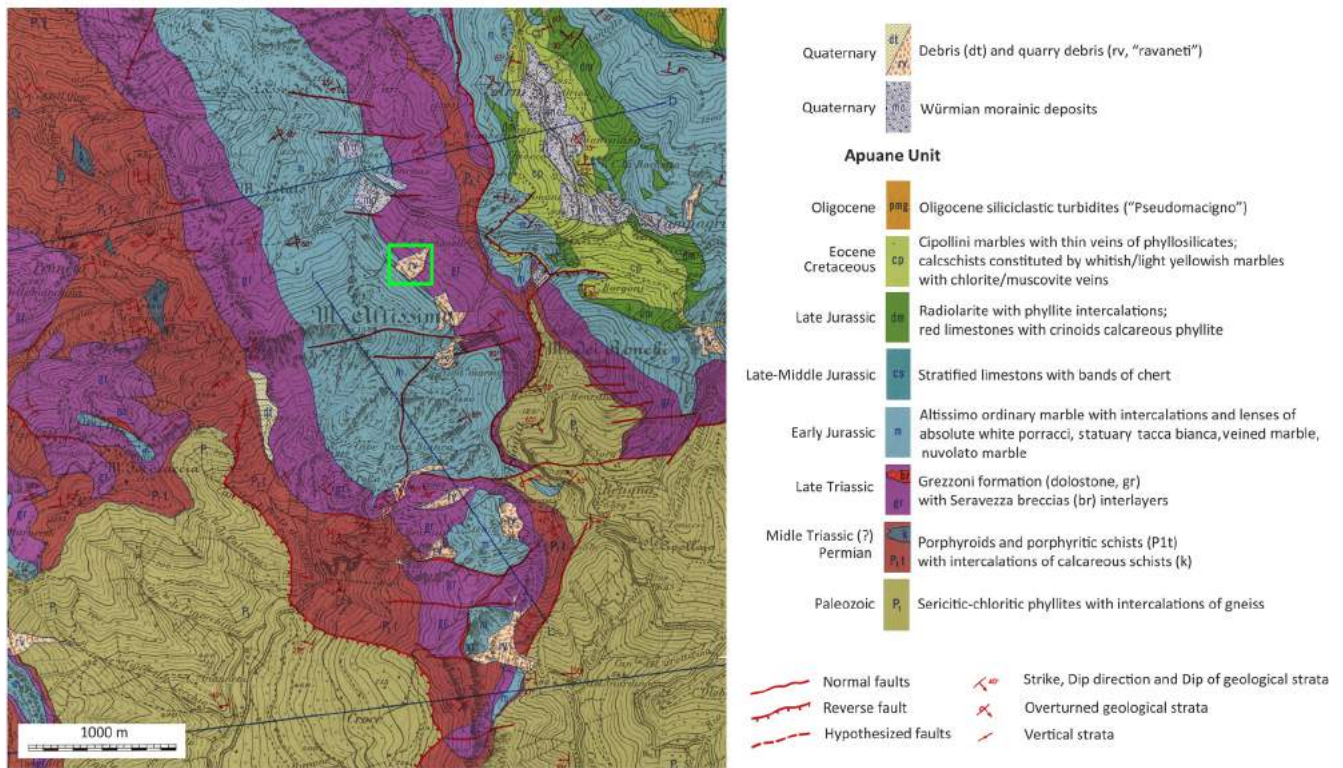
Mt. Altissimo geological map

Figure 2. Geological map of the Mt. Altissimo area. The green rectangle indicates the location of the quarry (modified from Giglia and Paiotti, 1963).

From a geological point of view (Fig. 2) the Piastrone open pit is located in the Apuan Alps metamorphic complex, precisely in the Mt. Altissimo Syncline (AS), belonging to the Apuane Unit (Meccheri et al., 2007). According to classical interpretation (Carmignani and Kligfield, 1990) AS resulted from a compressive tectonic phase which originated during the continental collision between the Sardinia–Corsica block and the Adria plate (Upper Oligocene–Lower Miocene). Successively, during the Early Miocene, a new ductile to brittle–ductile deformation caused by a post-compression

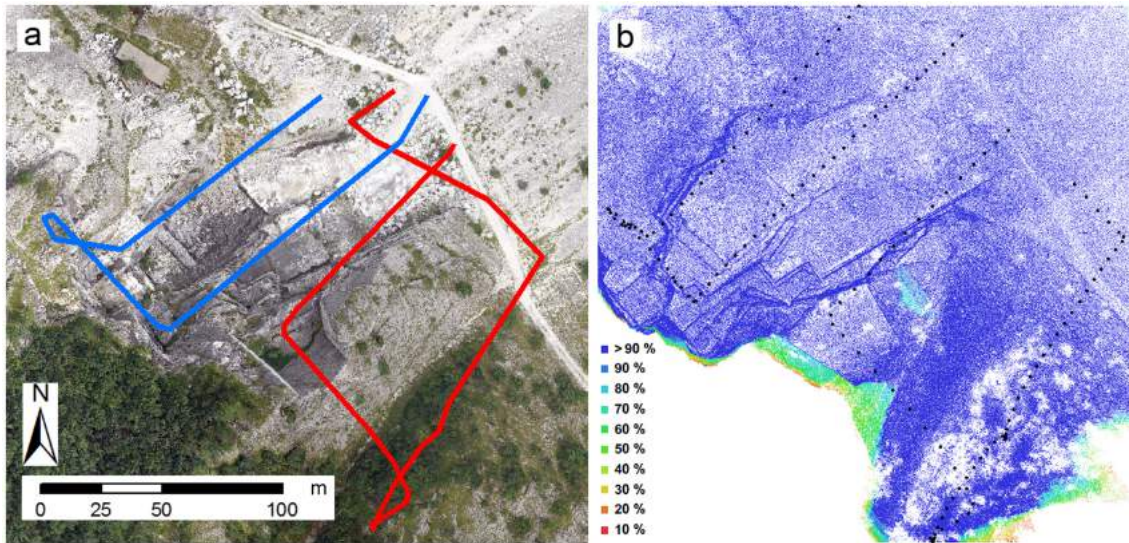
Figure 3. Flight paths of the RPAS zenithal surveys (a). Plan view of the area with indication of camera locations (black dots) and image overlap percentage (b).

The zenithal survey was preliminarily designed in the laboratory with the Aibotix™ AiProFlight planning software and manually performed through single quasi-parallel flight lines. A total of 151 aerial images were acquired with a nominal overlap and sidelap of 80 and 60 %, respectively. Two flights were required to cover all sectors of the mining area (Fig. 3).

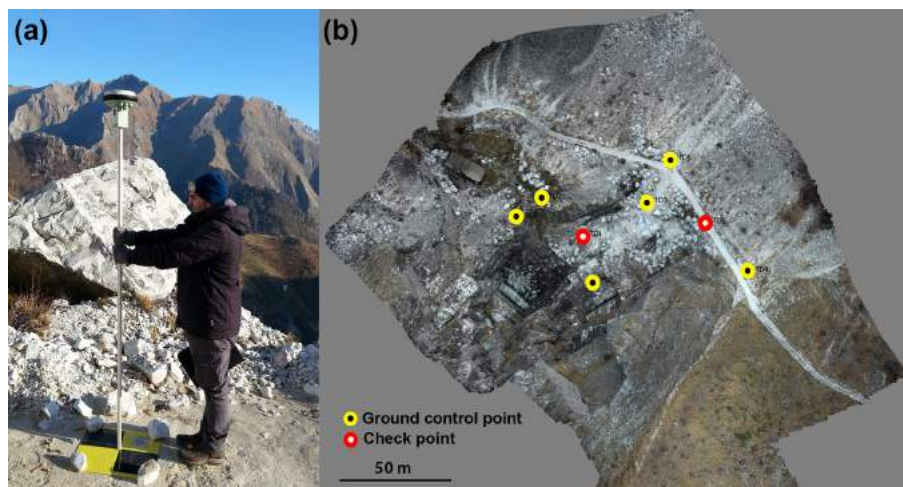
Figure 4. Example of a GCP measured during the RTK GNSS field survey (a) and spatial distribution of GCPs and check points for the RPAS zenithal flights (b).

An average estimated distance between pixel centres measured on the ground (i.e. ground sample distance – GSD) of 2.4 cm was calculated. During the flight, a GNSS field survey was also carried out in order to ensure the necessary spatial accuracy of the resultant images. Eight artificial targets, 50 × 50 cm large, were placed on the ground with the purpose of obtaining an optimum spatial distribution on the accessible zones of the study area (Fig. 4) and used as GCPs and check points.

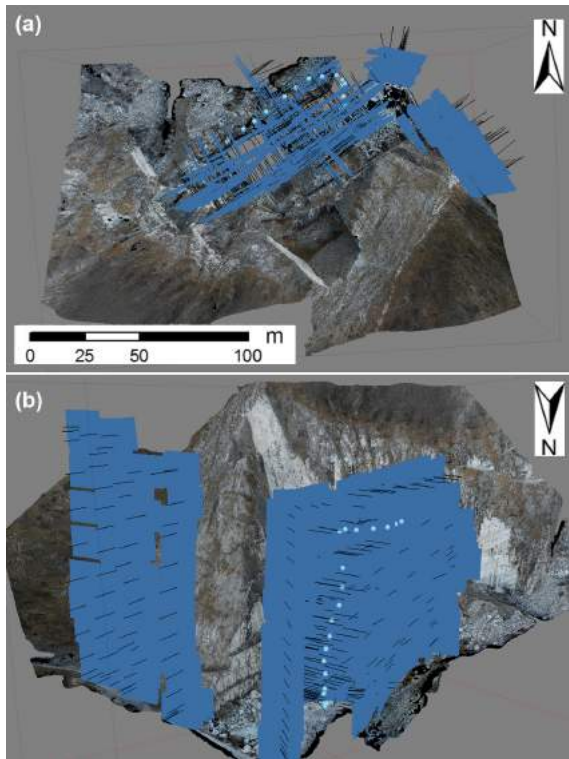
Figure 5. Plan view (a) and perspective view (b) of the RPAS frontal surveys (blue rectangles correspond to the photographs locations, black lines to normals). Corresponding 3-D point clouds produced by the photogrammetric processing of natural colour digital images are shown in background.

The frontal survey, with direction of acquisition parallel to the rock face, was carried out manually, without the use of the Aibotix™ AiProFlight planning software. Six flights were needed in order to cover all sectors of the mining area, resulting in a total of 448 overlapping images. The flights were executed in sub-parallel straight lines approximately 60 m distant from the rock face (Fig. 5), providing an average estimated GSD of 1.5 cm.

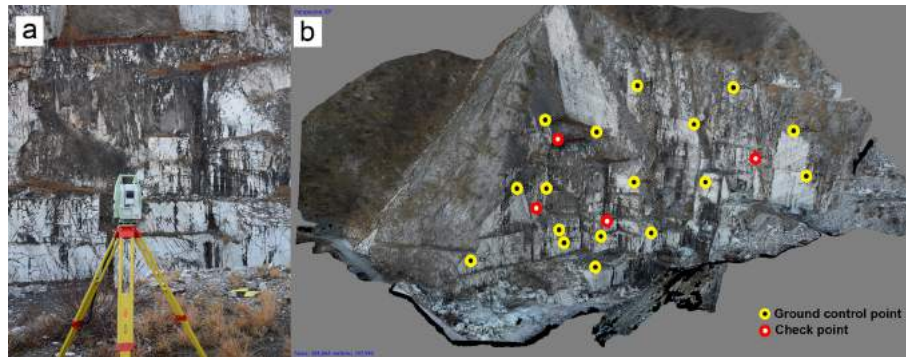
Figure 6. Topographic survey with TS (a) and spatial distribution of GCPs and check points for the RPAS frontal flights (b).

As for the zenithal flight, a series of GCPs and check points (21 targets in total; Fig. 6) were measured using a reflectorless TS. Their location was decided considering a balance between an optimum spatial distribution (Fig. 6),

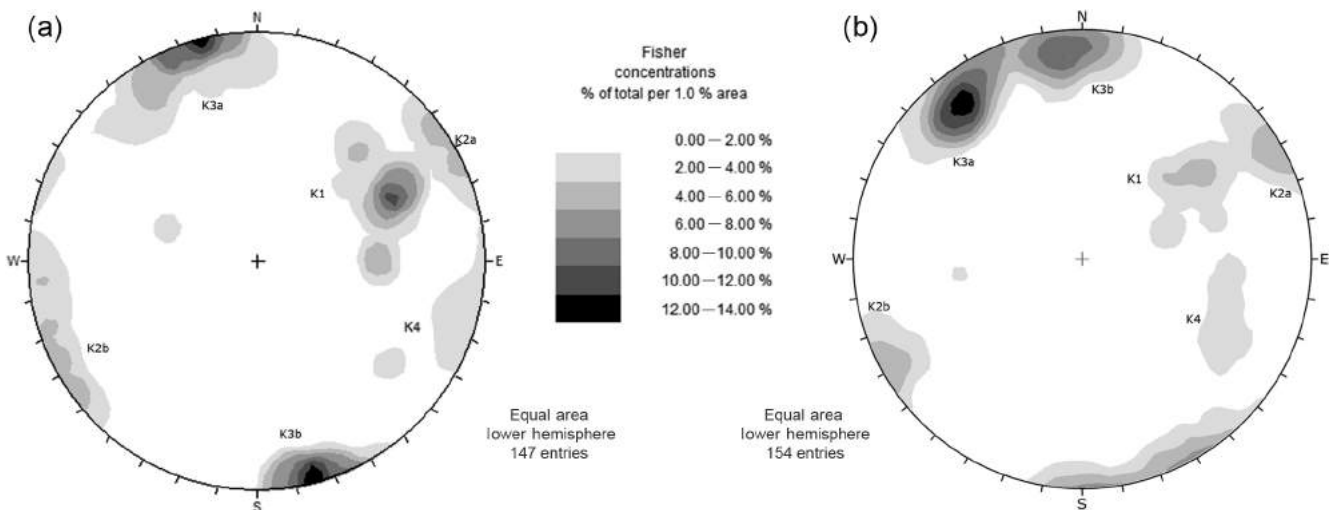
Figure 7. Stereonet plot of poles (Schmidt, equal area, lower hemisphere) of the discontinuities manually collected through classical engineering geological survey (a) and remotely collected by using photogrammetric data from RPAS surveys (b).

and that identified on the point cloud (in Fig. 7b), a good level of congruence has been highlighted, confirming the quality of the taken approach.

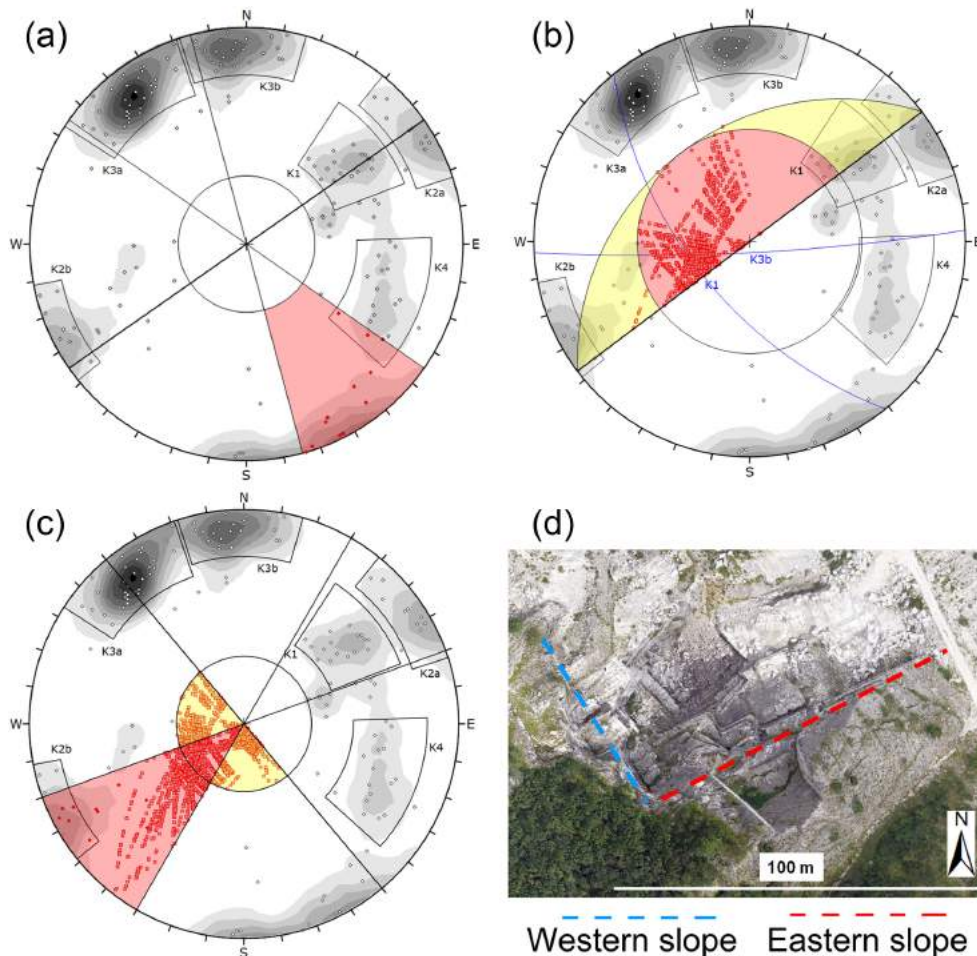
Figure 8. Examples of kinematic stability analysis carried out using Rocscience™ Dips 6.0 stereographic projection through the Wulff equal-angle method (lower hemisphere): (a) planar sliding on the eastern slope; (b) wedge sliding on the eastern slope (with highlighted great circles of intersection K1/K3b as example); (c) direct toppling on the western slope; (d) aerial photo showing the two principal slope orientations.

A discontinuity friction angle of 35° was used in the analysis: this agrees with data from previous studies carried out by the quarry’s advisors (Lorenzoni, 2012; Dumas, 1999), by the Geomechanical Laboratory of the Centre of GeoTechnologies of Siena University and literature (e.g. Chang et al., 1996; Perazzelli et al., 2009). Table 5 shows the potential failures identified through kinematic stability analysis (examples are shown in Fig. 8) for both principal slope orientations.

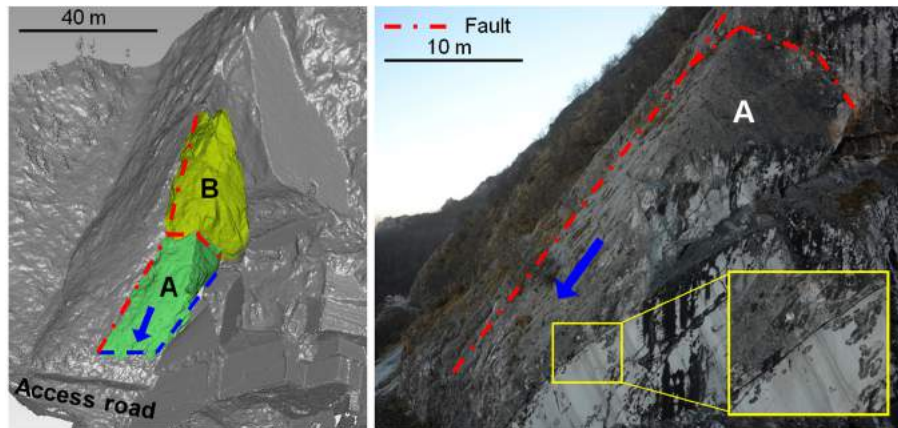
**Figure 9.** Identification of two large blocks with potential for sliding; inset photo highlights the visible aperture of the basal plane.

a few hundred cubic metres. In addition, the analysis identified two large blocks (Fig. 9), a few thousand cubic metres in size, with potential for sliding. These are formed by the intersection of two different faults and a discontinuity basal plane with 5 cm aperture, no infill, smooth surface and high persistence. The basal plane appears not to correspond with any of the identified discontinuity sets but is probably connected to

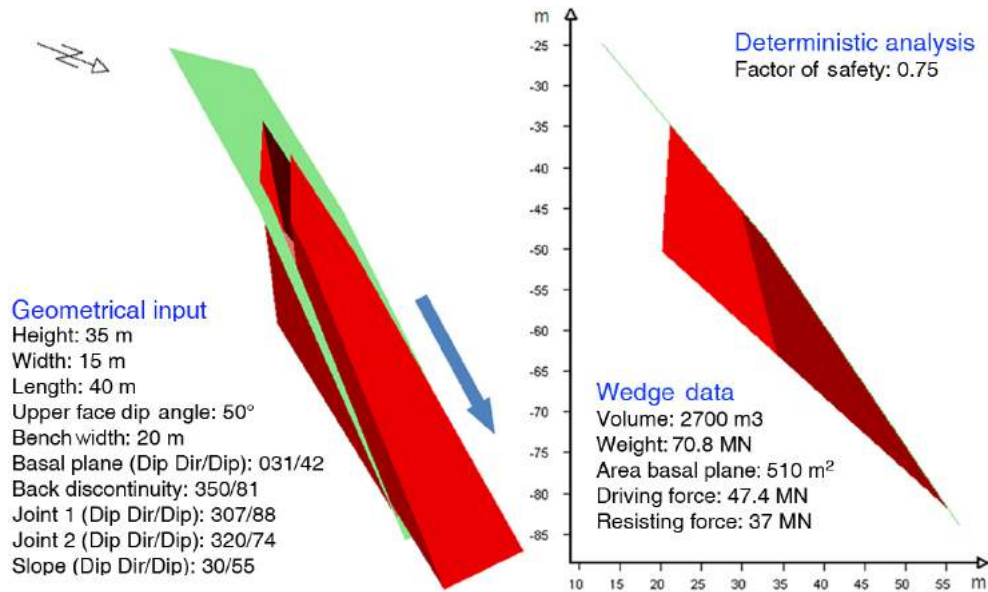
Figure 10. Result of Rocscience™ Swedge 3-D preliminary slope stability analysis.

The geometry of Block A was deterministically re-created in Swedge using the geometrical information shown in Fig. 10. Initially the discontinuities were assumed to be fully persistent. This is a common approach in engineering geology, since reliable values of persistence are almost impossible to obtain from field mapping and most rock slope stability analyses assume that the 100 % persistent joint exists on failure surface (Park, 2005). The basal plane is a joint and the possi-

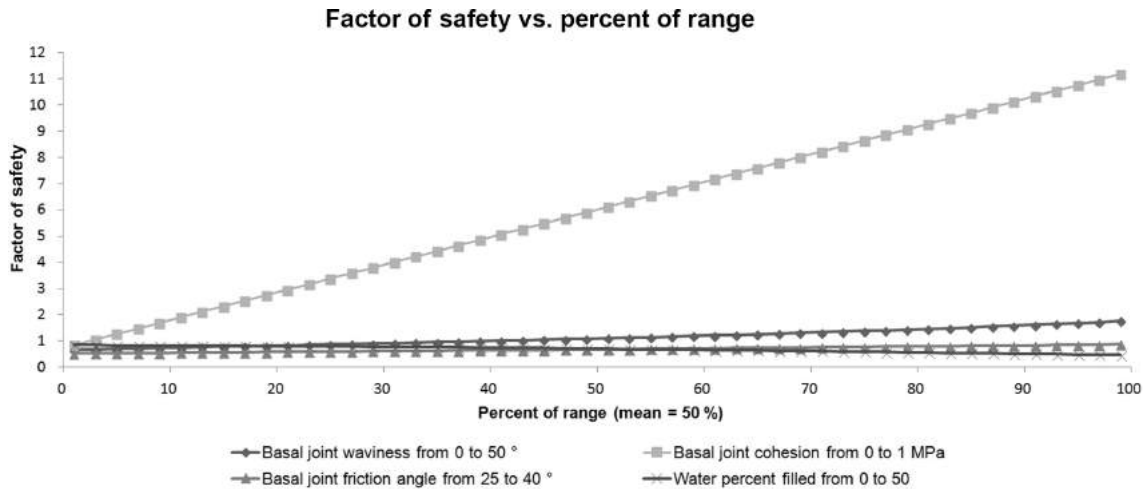
Figure 11. Result of sensitivity analysis relative to the parameters basal joint waviness, friction angle, cohesion and water percent filled.

The result highlights a possible condition of instability for Block A which does not match with field observations, since the block under study has remained stable in this position for tens of years. In order to investigate the effect of uncertainty or variability of the input parameters, a sensitivity analysis was performed. In a sensitivity analysis (Fig. 11) specific parameters are varied across a range of values and the ef-

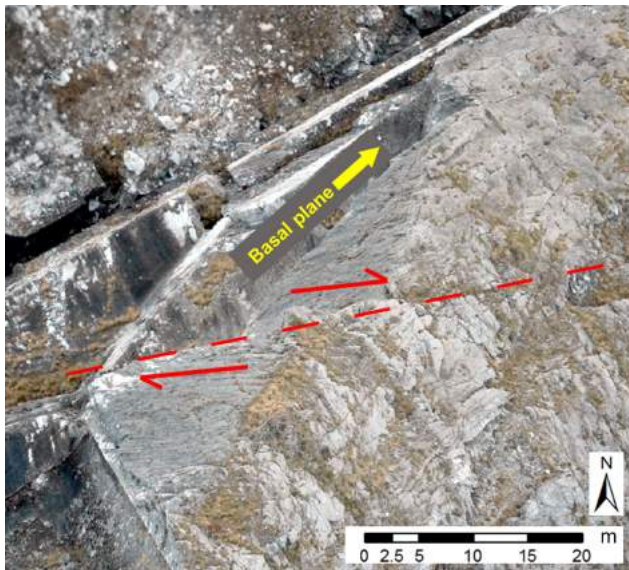
Figure 12. Detail of the zenithal orthophoto with indication of apparent offset of a major fault acting as back release surface for Block A of Fig. 9.

In the preliminary limit equilibrium analysis, the major uncertainty is on the basal plane (Fig. 12). Despite the presence of a continuous trace line on the rock exposure, its full persistence in the rock mass is not clear. In general, the presence of rock bridges plays an important role in stabilizing removable rock blocks. Indeed, a rock block cannot fall or

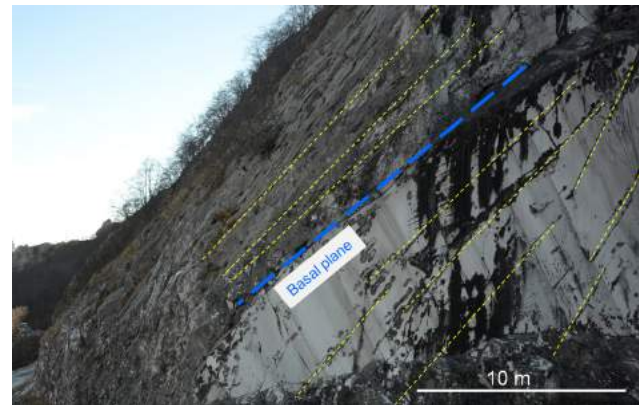
Figure 13. Details of a series of tight discontinuities above and below the basal plane under study.
