## Remote sensing and ground survey of archaeological damage and destruction at Nineveh during the ISIS occupation

# Remote sensing and ground survey of archaeological damage and destruction at Nineveh during the ISIS occupation

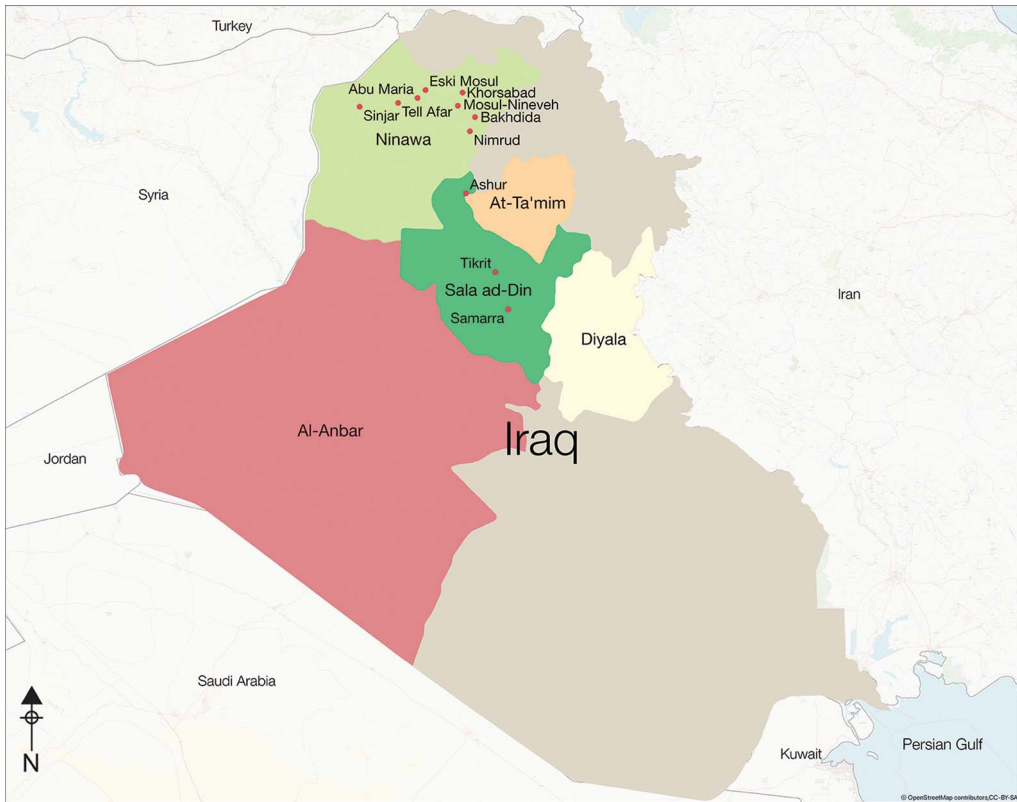
Figure 1. Iraqi governorates and selected archaeological sites, listed in collaboration with the Iraqi authorities and analysed by monitoring site transformations through remote sensing (sites listed in Table 1) (figure by S. Campana).

The first phase of the initiative, from December 2014 to November 2016, produced a geo-database of archaeological and cultural heritage sites in the five Iraqi governorates once entirely or partly under the control of ISIS (Figure 1). An assessment and monitoring of

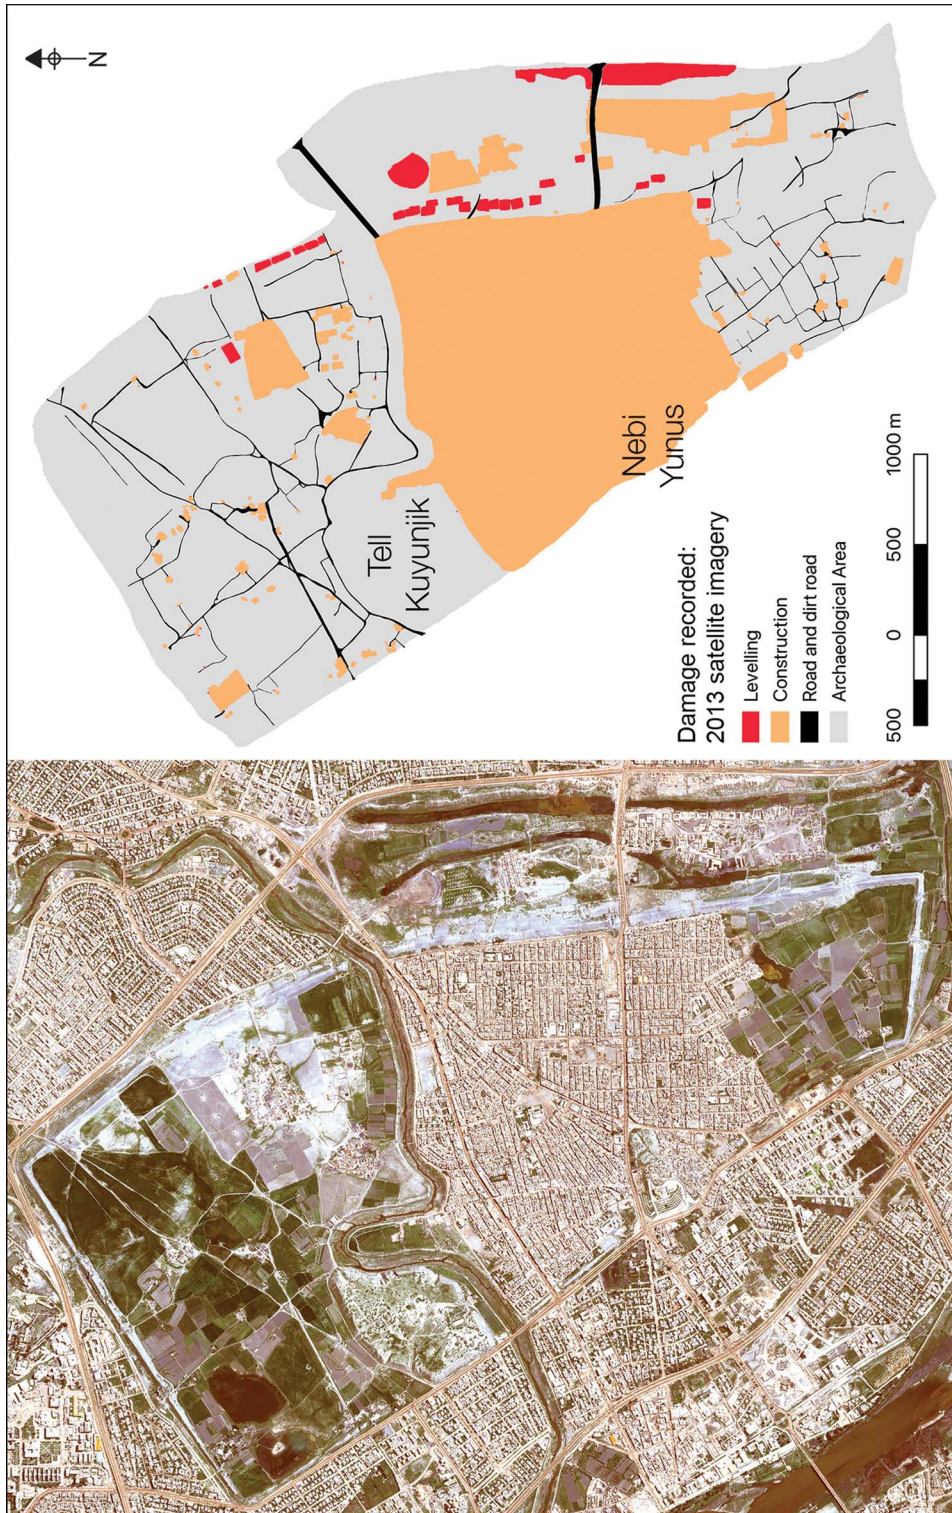
Figure 2. Satellite image of Nineveh (WorldView-2 imagery acquired 15 November 2013) (left) and analysis of pre-ISIS damage and destruction (right) (figure by S. Campana).

In 2013, the area within the city walls already showed evidence of serious damage. The full extent of the ancient city was calculated to be approximately 1067ha, and the 2013 imagery shows surface damage of various types across some 375ha—around 35 per cent of the city. The most serious losses were due predominantly to the urbanisation of the central part of the city and to bulldozing or other forms of levelling for a variety of purposes within the peripheral areas. The threat to the preservation of Nineveh caused by its proximity to the expanding suburbs of Mosul had already been highlighted in previous decades when the SBAH, local authorities and international bodies initiated projects to oppose, or at least partially arrest, this trend. Account must also be taken of damage associated with a dense internal network of unpaved roads and modern agriculture, the impact of which—though difficult to quantify—is of central importance for the first metre of stratigraphy across most of the non-urbanised areas of the site, with the exception of Tell Kuyunjik and of the embankment that still surrounds much of the city walls (Figure 2).

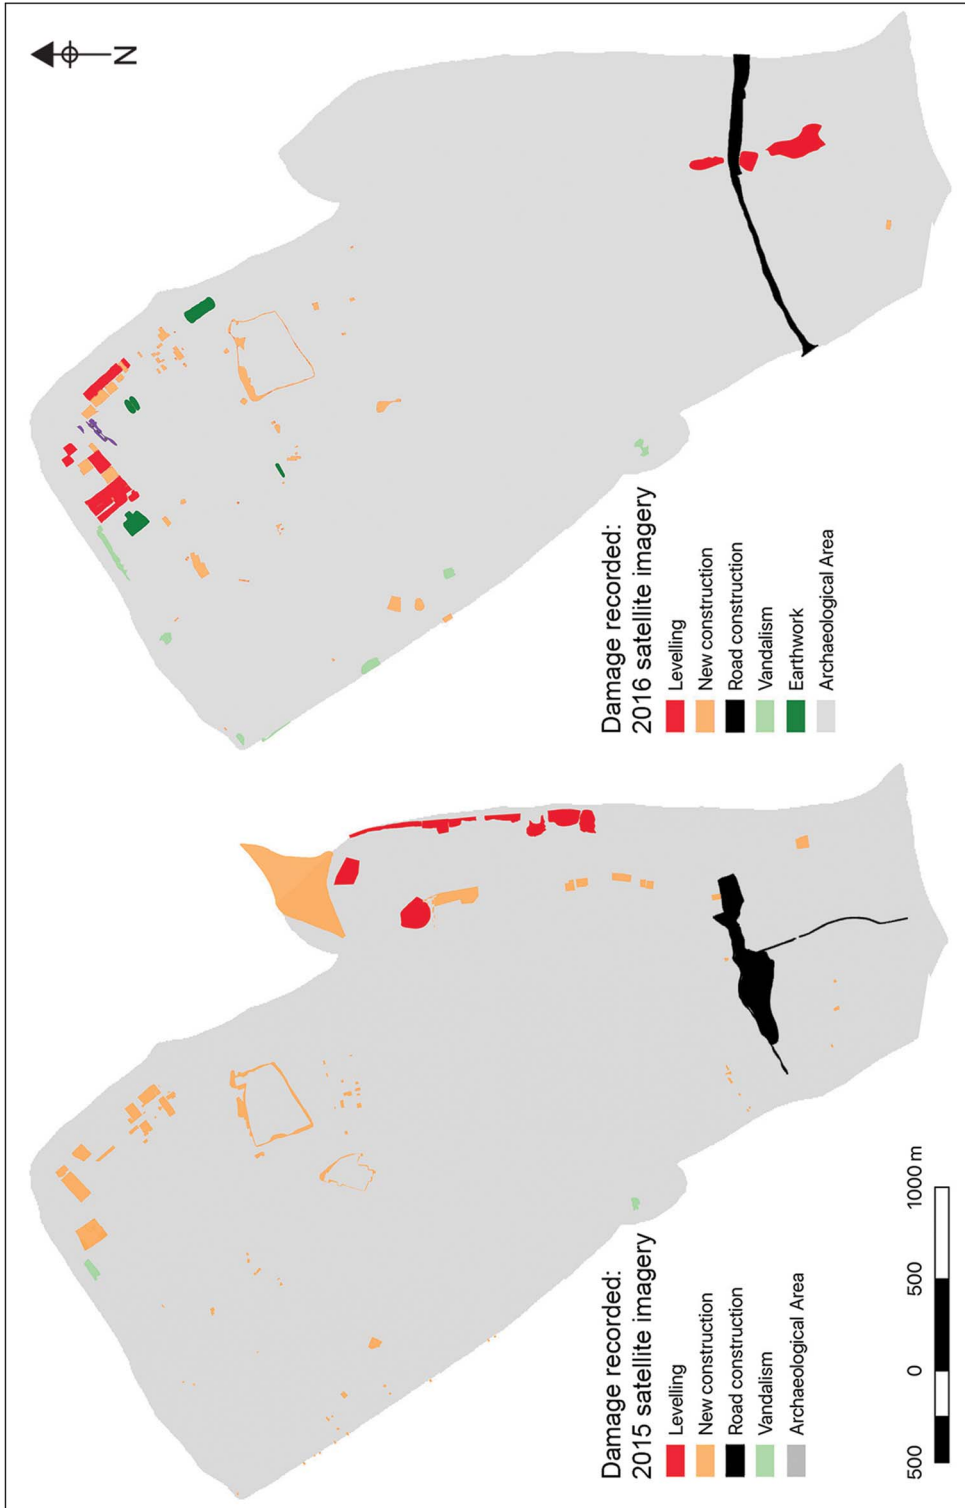
Figure 3. Categories of damage detected and dated by comparing the results of satellite imagery from 2015 and the latter part of 2016 (figure by S. Campana).

Under the ISIS occupation, known damage to the city of Nineveh includes that caused by the infamous bombing of the religious buildings on Tell Nebi Yunus in August 2014, bulldozing in 2015, the defacement of parts of the city walls and gates, and attacks on the colossal sculptures at the Nergal Gate and the interior of Sennacherib’s palace in 2015. The later satellite imagery (2015 and 2016), however, demonstrates that the worst damage to the integrity of the site, and hence its future cultural appreciation, was from construction projects already completed or still in progress by the end of the ISIS occupation—principally the building of a two-lane highway and the clearance of extensive areas for private housing (Figure 3).

The impact of surface disturbance (or ‘land consumption’) during the two years of ISIS occupation amounted to a total of 85ha, of which 3.5ha (4 per cent) is related to vandalism and 78ha (91 per cent) to new settlement or infrastructure schemes. These activities were facilitated by the complete abrogation of the heritage protection acts during the ISIS administration, both at Nineveh and elsewhere (Casana & Laugier 2017). The relatively limited amount of deliberate ideological destruction by ISIS at Nineveh should nevertheless not be underestimated, as these assaults were directed predominantly at specific monuments and features of outstanding cultural and archaeological value; the destruction of such features across 3.5ha of the city represents a loss of enormous significance. Finally, 11 enormous rectangular anomalies, orientated roughly east–west and measuring between 50 and 110m in length, 15 and 50m in width and up to 6.5–7m in depth, were identified in the satellite data in the northern part of the city (Figure 4: right). Despite much speculation by our team, the correct interpretation of these features was not established until they were later examined during ground-based survey, as described below.

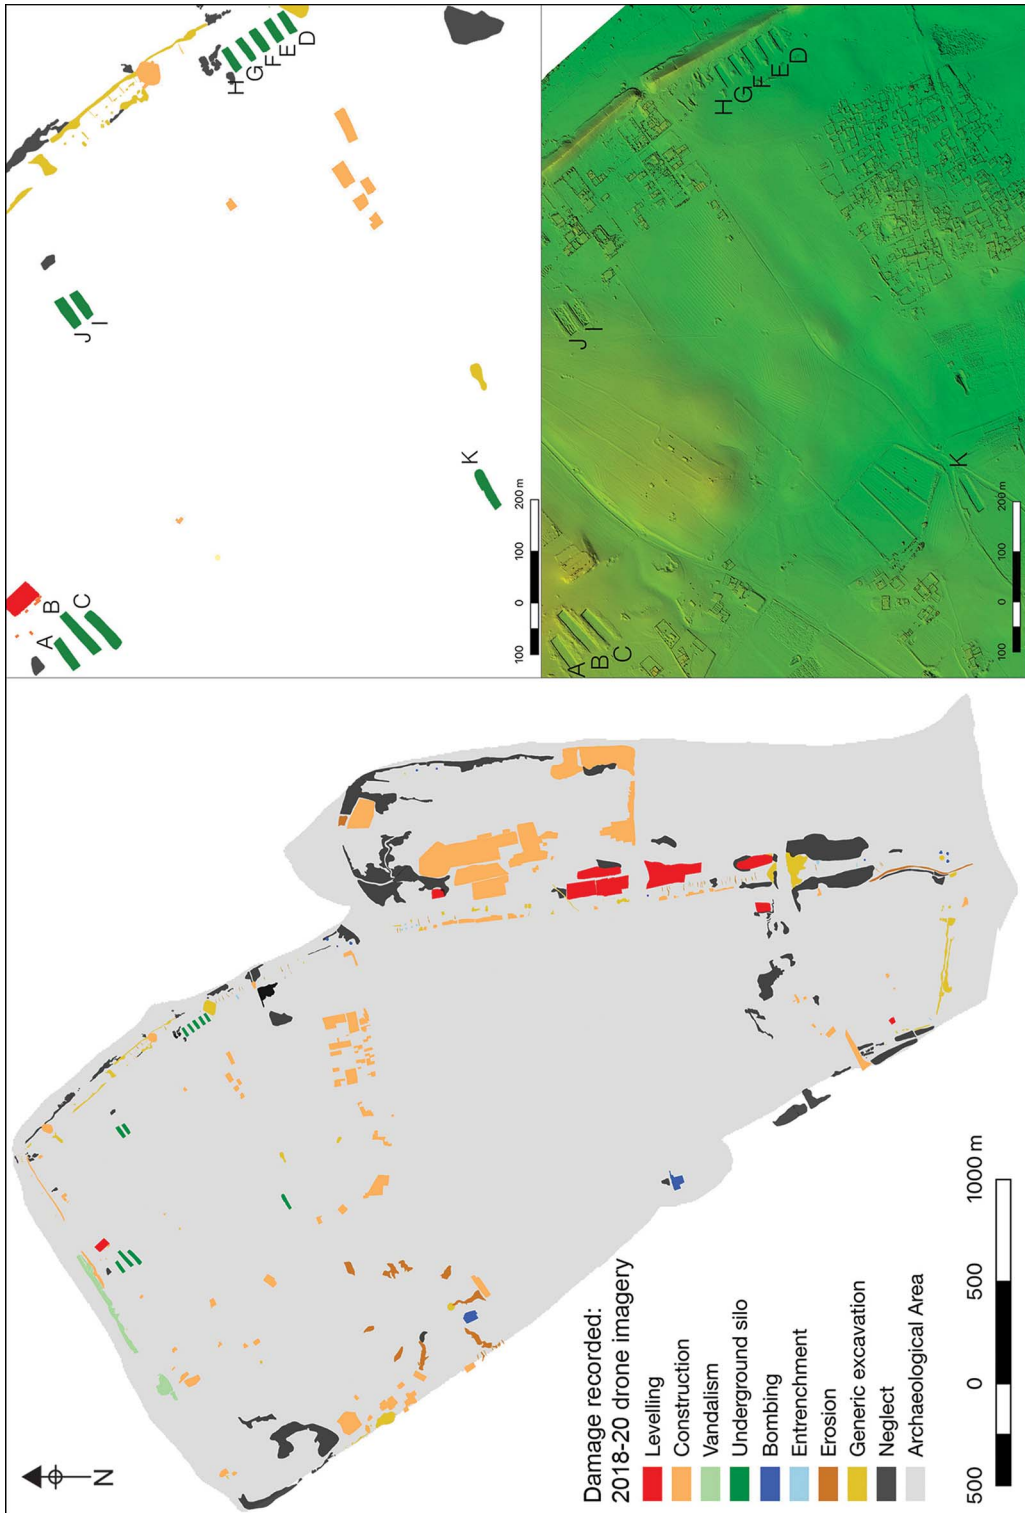
Figure 4. Left) Map of damage identified by drone survey, visualised by categories; top/bottom right) detail (A–K) of the ISIS excavation of underground silos/granaries (figure by S. Campana).

Among the most striking and irreparable instances of damage encountered during the survey are a series of ‘underground silos’. These structures correspond to the large, distinctive

anomalies identified on the satellite imagery that we were initially unable to assign to a specific interpretative category. Drone reconnaissance, site inspection and testimony from local SBAH officials eventually identified these anomalies as huge, rectangular trenches dug by ISIS and used to store grain reserves and other materials (Figures 4 & 7–8). The total area affected by these silos was 1.2ha; in some cases, they reached a depth of 8m, irreversibly compromising the archaeological stratigraphy. Based on the photogrammetric surveys, the

construction of the silos removed an estimated 50 000m<sup>3</sup> of sub-surface deposits. Further details are provided in the section below detailing the ground-based survey.

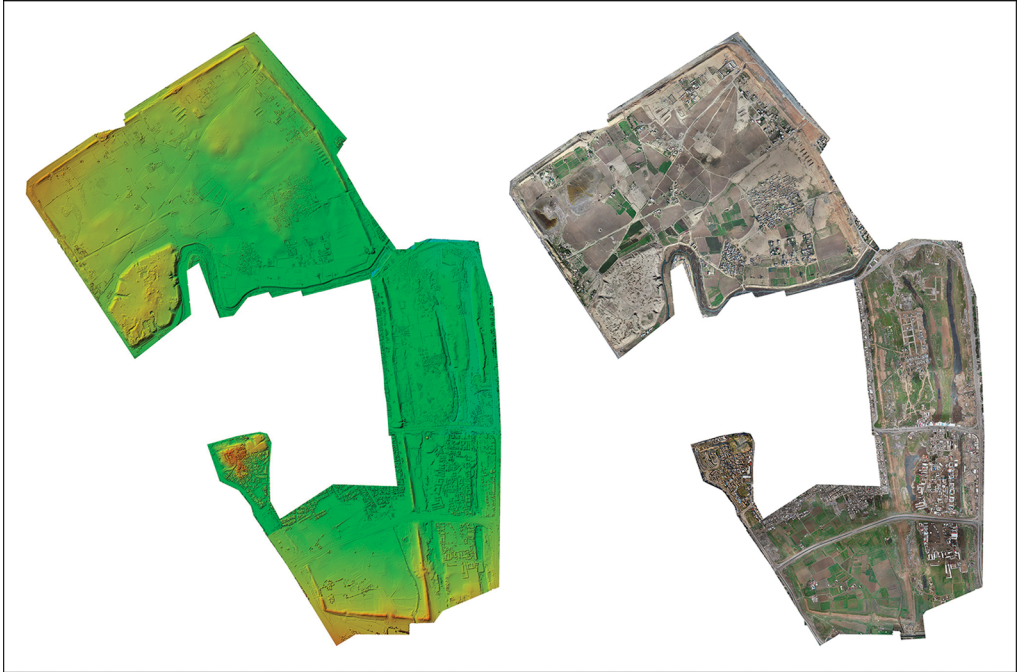
Figure 5. Left: Digital Surface Model processed from drone-based photogrammetry (yellow tones for higher land, green for lower land); right: orthophoto map processed from the photogrammetric images (figure by S. Campana).

covering a total area of approximately 812ha (Figure 5). Processing allowed the creation of a detailed DSM of the city's topography, capable of producing high-resolution orthomosaics to aid detailed inspection and monitoring of the condition of each individual context.

The improvement in ground resolution for the drone (approximately 20mm) compared with that of the satellite imagery (0.5m for Worldview-2 and 0.3m for Worldview-3) was substantial and resulted in a greater ability to identify and characterise the damage recorded on the satellite imagery. Moreover, the high-resolution DSM significantly increased our capacity to interpret the evidence on site with greater confidence. Data analysis was carried out using both the DSM and the orthomosaics from the drone photography.

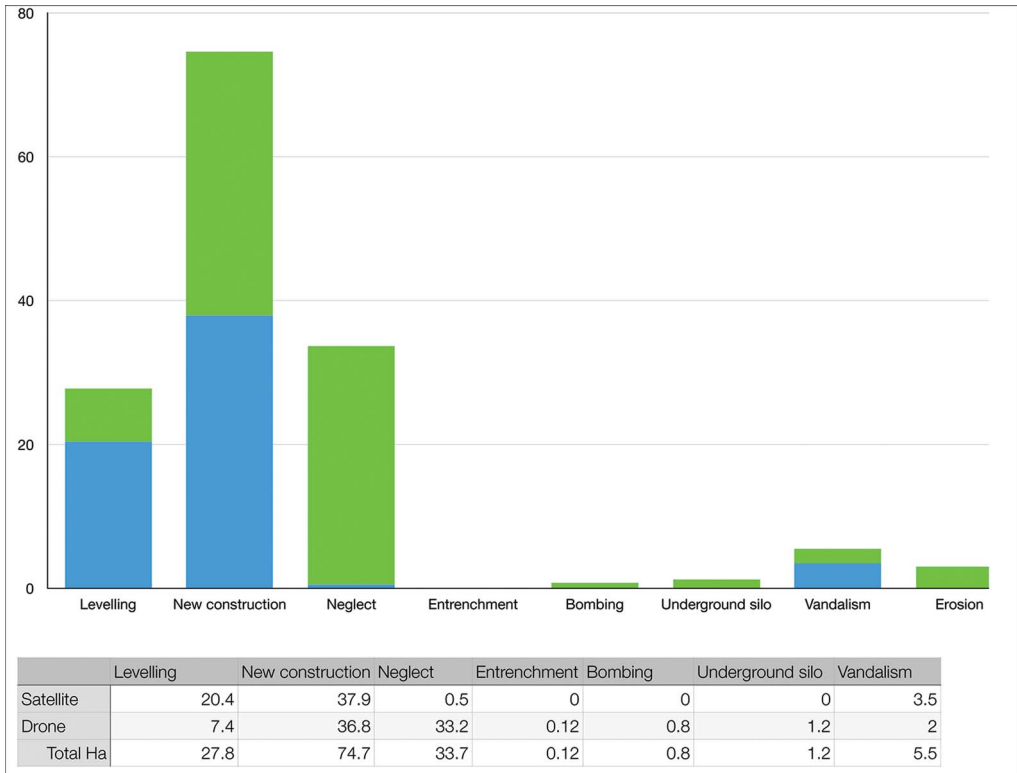
Figure 6. Types of damage identified by satellite (blue) and by drone survey (green), measured in hectares (figure by S. Campana).

Figure 6 shows the distribution and quantitative correlation between the satellite evidence and that acquired by drone. Alongside vandalism of the city walls, gates and Sennacherib's

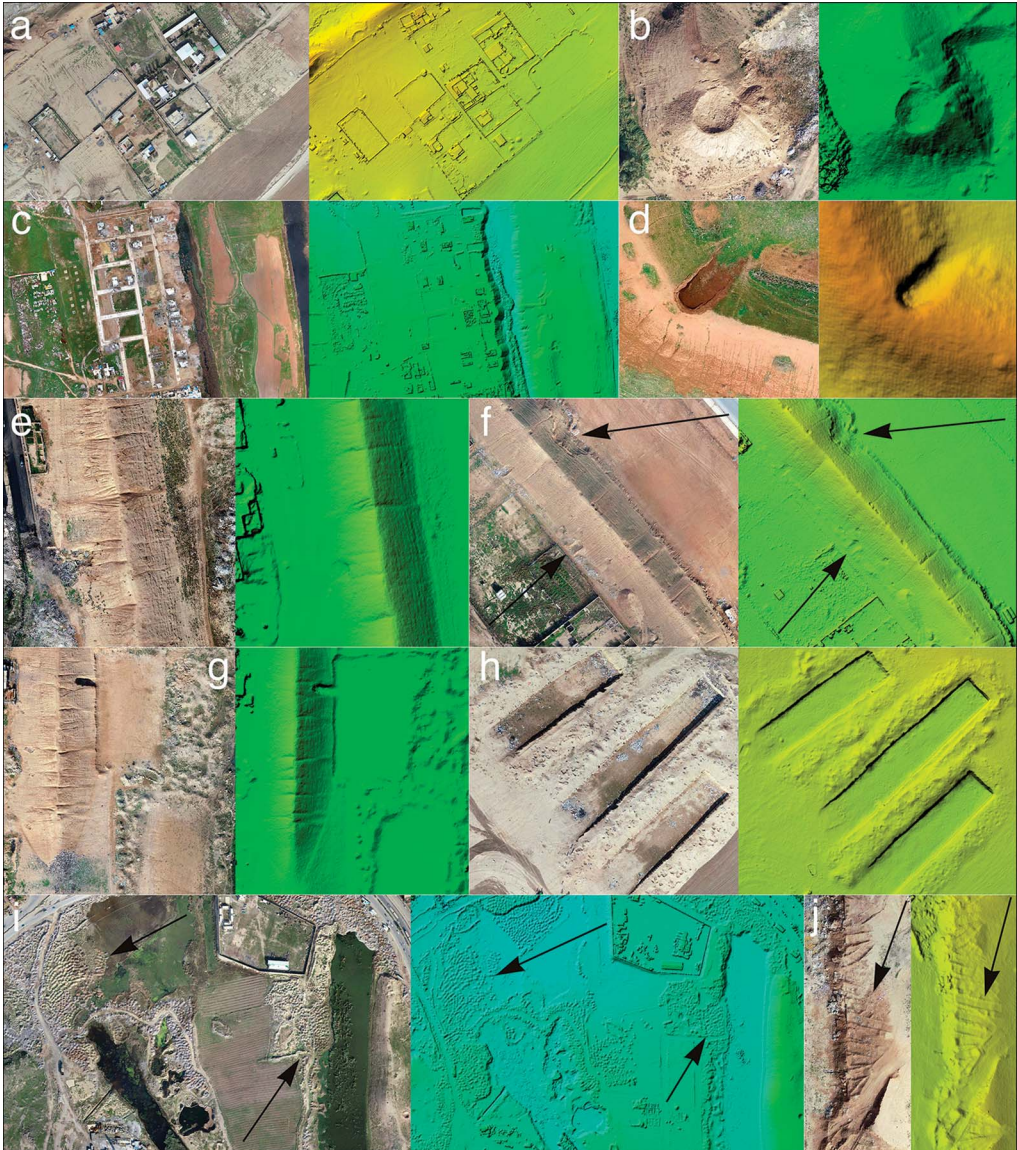
Figure 7. Representative examples of the main types of damage, shown in each case as drone-based air photography (left) and Digital Surface Model (right): a) new constructions; b) bombing; c) new constructions; d) entrenchment; e) erosion; f) excavation (marked by arrows); g) levelling; h) underground silo; i) neglect (examples marked by arrows); j) vandalism (marked by arrows) (figure by S. Campana).

palace (Figure 7j), serious deterioration of the archaeological area caused by urban development, neglect and damage directly related to the conflict is evident.

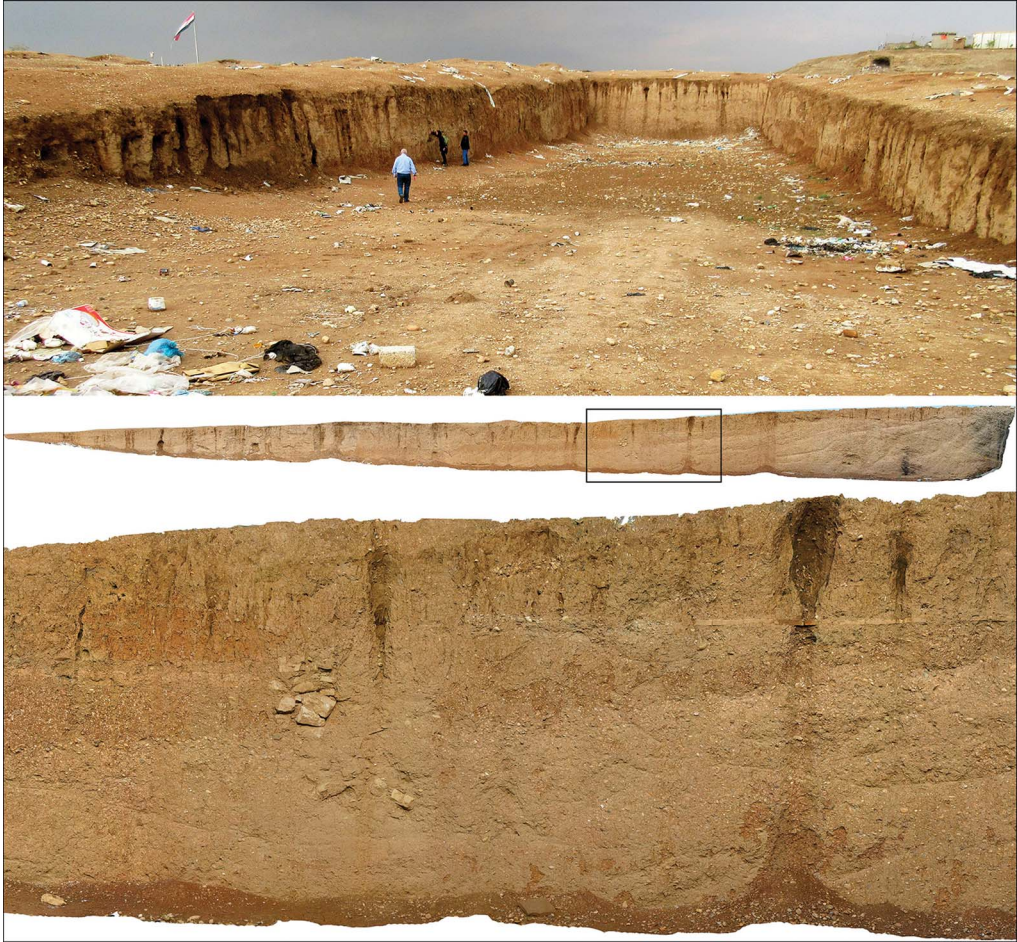
*Figure 8. Nineveh, November 2018: top) view of Trench B, one of the so-called ‘granaries’ excavated by ISIS, looking west (note the accumulation of various types of rubbish); centre and bottom) orthophotomosaic of the west section, demonstrating the complexity of the archaeological stratigraphy removed by the creation of the granaries (photographs by the authors; figure by S. Campana).*

Within the city walls, the most striking instances of damage were the 11 huge excavations identified by local people as 'granaries' ('underground silos' in the drone-based interpretation layer). Consistently orientated approximately west–east, they were all located within the northern sector of the ancient city, in three groups, with a single outlier further to the southwest (labelled A–C, D–H, I–J and K in [Figure 4](#)). Ground inspection showed that they had originally been covered by plastic sheeting and probably a layer of soil. In building these structures, ISIS has irrevocably destroyed a large portion of the unexcavated city, down to the natural geological substratum. [Figure 8](#) illustrates the extent of the destruction, which removed an estimated 50 000m<sup>3</sup> of stratified archaeological deposits, along with an incalculable quantity of ancient artefacts, the present whereabouts of which remain unknown.

Trenches A, B and C each measure approximately 80–100m in length and 30m in width. Two complete sections, documented by photogrammetry, demonstrate that a densely built-up area was destroyed, including a monumental, approximately 4.5m-wide mudbrick wall running north–south between Trenches B and C. In addition to mudbrick structures, the section of Trench B revealed brick-paved floors, pits, two wells, and massive fills containing pottery. Scattered on the disturbed surface, among recent debris, were Palaeolithic stone tools, numerous Neo-Assyrian and possibly later pottery sherds, fragments of Assyrian stone vessels, grinding stones and a large fragment of a gypsum doorsill.

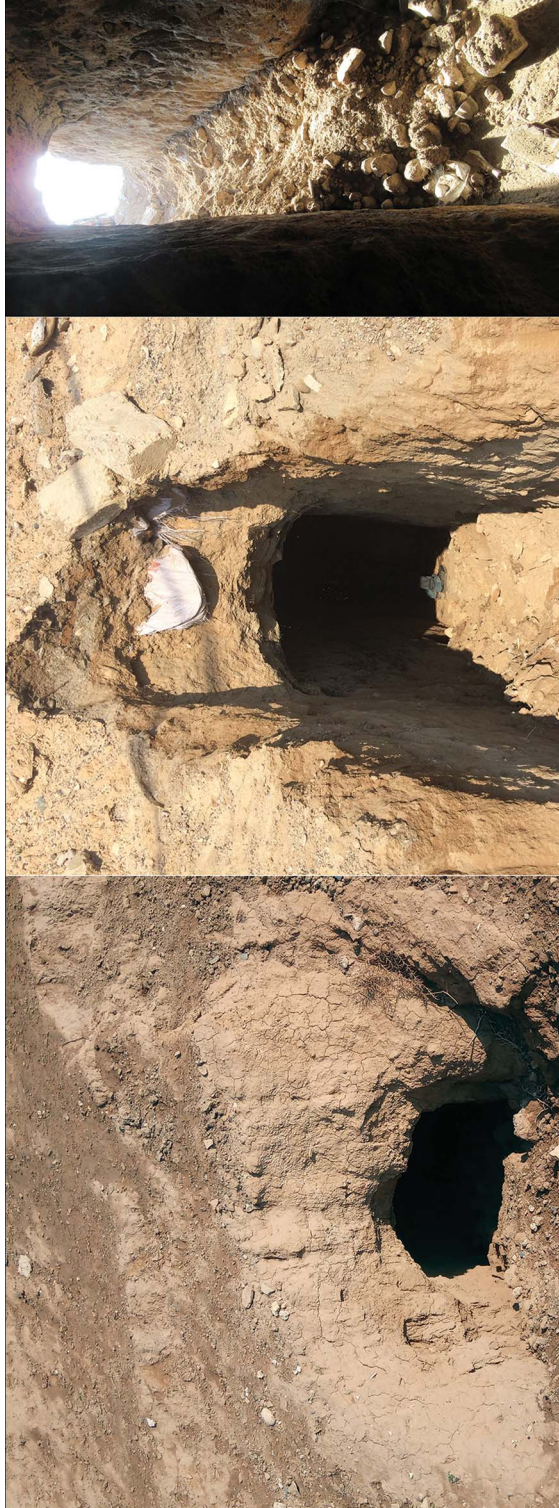
*Figure 9. Tunnels surveyed at Tell Kuyunjik in November 2018 (photographs by the authors; figure by S. Campana).*

Finally, features identified by ASOR as tunnels, possibly intended for looting, were inspected. At Tell Kuyunjik, the presence of a dense network of recent tunnels (Figure 9) was confirmed. These were probably excavated by ISIS to facilitate (and conceal) the movement of materials and people. There was, however, no evidence to support any relationship with looting. Nevertheless, similar tunnels across the whole of Nineveh deserve further investigation and mapping; indeed, the use of tunnels has a long history in Mosul, at least in Nebi Yunus and Kuyunjik, where, since Layard's excavations in the mid-nineteenth century, this has been an established method of bypassing the massive Parthian and Sasanian occupation levels and speeding up the exploration of the Neo-Assyrian remains (Rassam 1897).
