The gravitational landscape of Montespertoli (Valdelsa Basin, Tuscany, Italy): State of activity and characteristics of complex landslides

THE GRAVITATIONAL LANDSCAPE OF MONTESPERTOLI (VALDELSA BASIN, TUSCANY, ITALY): STATE OF ACTIVITY AND CHARACTERISTICS OF COMPLEX LANDSLIDES

Keywords: Landslide, State of activity, Rate of movement, Geomorphological map, Tuscany

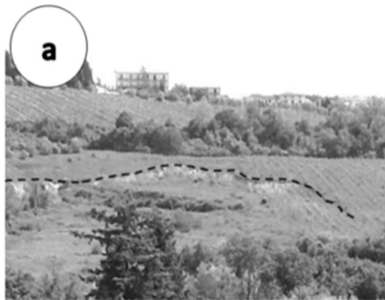
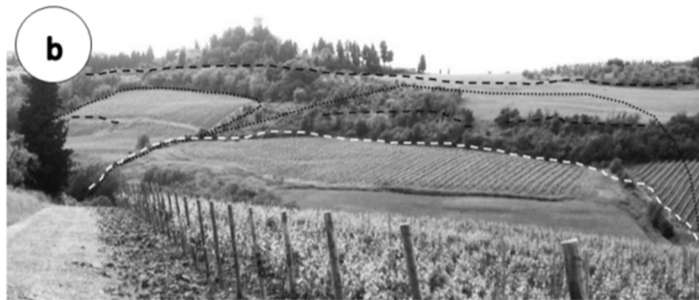
Figure 4

Fig. 4. Evidences of landslides within the study area: (a) scarp associated with a flow that affects a vineyard; (b) view of landslides 3 (right) and 4 (left) affecting the left side of the Torrente Orme. From top to bottom: main escarpment, secondary scarp (in black), and portion of the body which is flowing (area marked white); (c) undulations and cracks in a secondary road associated with landslide 5. [2 COLUMNS]

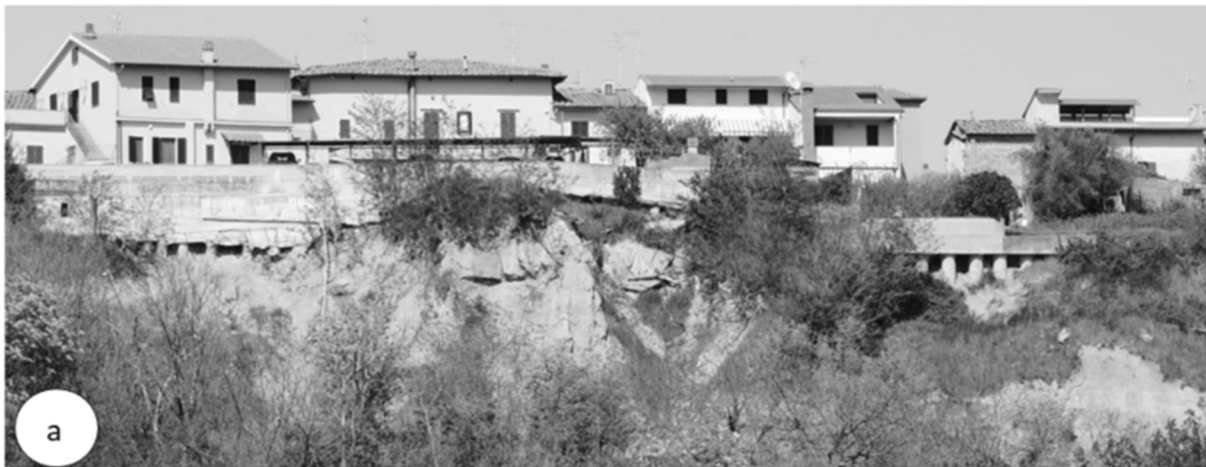
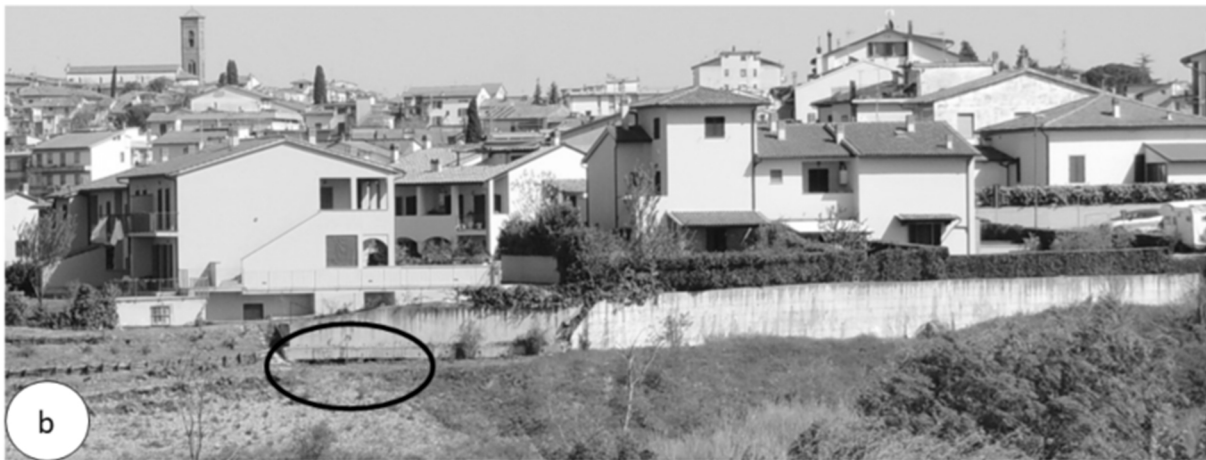
Figure 8

Fig. 8. Photographs of landslides. (a) Landslides 11 and 12 nearby La Fornace area: main escarpment and detail of the bulkhead poles with bead head; the poles are undermined and fractured. (b) Landslide 13: view of bulkhead of piles below a new building on the Suor Anselmi Street on the left and the gas station on the right. The undermined bulkhead of piles is marked with a black circle. [2 COLUMNS]

The top of the main inner escarpment is located at an elevation of ~230 m, nearby the buildings facing the SP Volterrana and San Ripoli streets. The foundations of several buildings (Fig. 8a), parts of the parking floor and the San Ripoli street have been damaged. Cracks parallel to the scarp and undulations are clearly recognizable above the crown area, marking embryonic, concentric,

This landslide is in the north-western periphery of the town north of the junction between SP Volterrana and Mandorli Streets, at the head of the Turbone Stream (Fig. 6a,b). The landslide has three main bodies, each with its own escarpment, although the southern one is more evident. Minor landslides also affect the escarpment east of this area, where a group of houses were built between 2003 and 2007. The scarps, the top of which is located at an average elevation of 230 m, have a height between 5 and 10 m. The western and eastern scarps laterally extend over a total length of ~235 m and ~155 m, respectively, and were affected by intense anthropogenic remodelling, firstly associated with intense agricultural work and later with progressive urbanisation. Major damages were recorded in correspondence of a Gas station, where a retaining wall had to be built because of the progressive fracturing and displacement of the armoured concrete platform foundation, which hosted a carwash, and part of the main road surface. To prevent further movement, the upper part of the landslide scarp was reinforced by bulkhead of piles with a reinforced concrete beam. Their upper part is now undermined by diffuse degradation processes. Recent movements also occurred below a new group of houses (Fig. 8b).

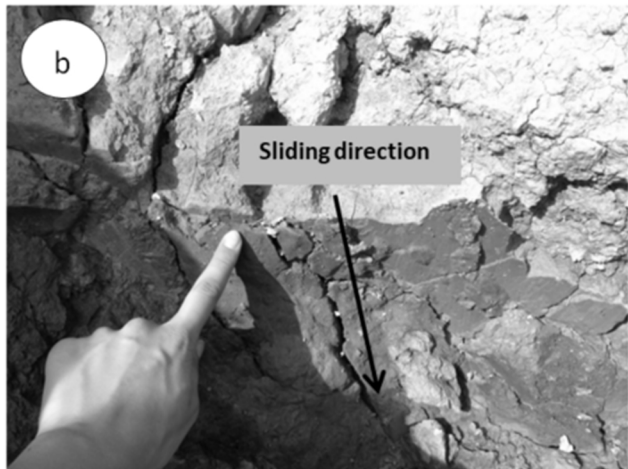
Figure 9

Fig. 9. Outcrop of the landslide body consisting of sand, silt, and clay near Amedeo Bassi Street:

- (a) tilted layers lie over a superficial sliding surface; the layering of deposits is shown in black and the major fractures are shown in white;
- (b) fracture system associated with the shearing surfaces;
- (c) fracture systems within the clay. [2 COLUMNS]

Evidence of the type and behaviour of the landslides that affected the area was found in the middle part of the Volano landslide (landslide no. 4, Fig. 9) within an area affected by gully erosion due to the construction of a depuration system. The escarpment of the gully cuts several metres of sands and silty–clayey bedrock. The outcrop shows that the landslide consists of a series of bodies moving at different velocities. In fact, the upper part, few metres thick, is sliding over a subhorizontal layer of sands. The sliding surface is very sharp and the body has a series of sandy layers tilted $\sim 20^\circ$ upslope in the innermost part (Fig. 9a). The tilting affects also the silty–clayey layers cropping out below the sands, although the layering is less recognizable. This thin body is affected by a limited number of fractures, which are normal to the tilted layers and spaced several metres apart from each other. The horizontally layered sands below the sliding surface of the uppermost body are affected by a thick network of vertical fractures with 20–50 cm spacing. Below this level there are gray–greenish clayey–silty deposits, which are intensely fractured and intercalated with decimetre-thick fossiliferous dark layers. The clays and silts are cut by three main sets of fractures and small faults, which are the result of the fragile landslide behaviour:

- a) system 1: N 90° S 85° (Fig. 9b)
- b) system 2: N 20° E 65° (Fig. 9c; black lines);
- c) system 3: N 180° W 90° (Fig. 9c; white lines).

The evaluation of the relationships between the fracturing systems allows the reconstruction of their relative chronology. System 2 is the more recent one because it cuts system 3.

Landslide 4 is a complex landslide consisting of a deeper rock slide with a horizontal sliding surface covered by a shallow rock/earth flow. The upper part of the large slide does not show evidence of active dynamics since 1954, maybe before. In the 1954 – 1988 interval the middle–lower part of the landslide was already affected by an active slide evolving into a flow and by flows, while the lower part was affected by earth/rock flows. The thickness of a landslide could be estimated based on the height of the escarpment and the thickness of the homogeneous rocks involved. The localisation of the sliding surface inside a sandy layer (Fig. 10a) could be associated with the existence of confined water pressure. The outcrop along the banks of a gully in landslide 4 shows an unexpected brittle behaviour of the clay layers (Fig. 9).
