Classification of natural and engineered rock slopes using UAV photogrammetry for assessing stability

N Bar¹, L Borgatti², D Donati², M Francioni³, R Salvini⁴ and M Ghirotti⁵

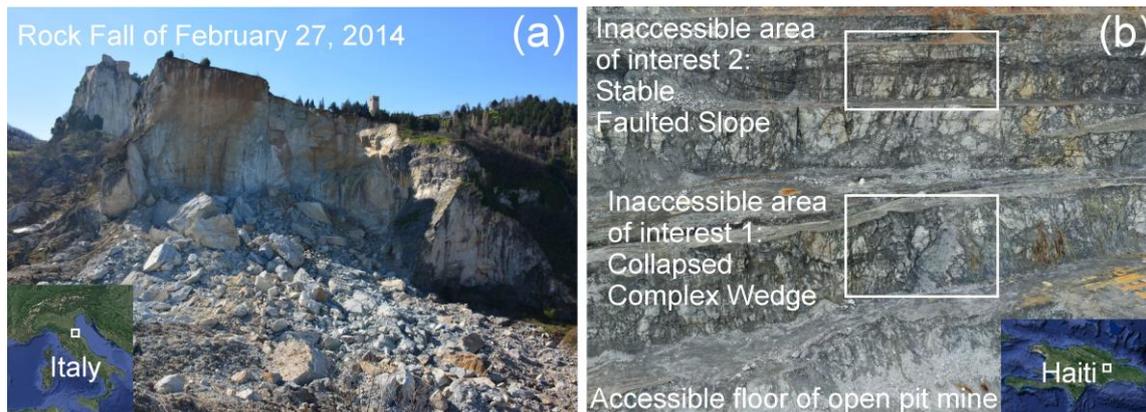
Figure 1. The case studies: (a) the scarp of the 2014 San Leo rock fall; (b) unreachable benches of an open pit mine in the Caribbean.

In this paper, two case studies, represented by the San Leo (natural) slope in Italy and individual benches in an open pit mine in the Caribbean are shown (figure 1), with the goal of demonstrating how output from UAV photogrammetry can be adopted for applying the Q-slope method in rock slope engineering for natural and excavated slopes which are otherwise not safely accessible on foot.

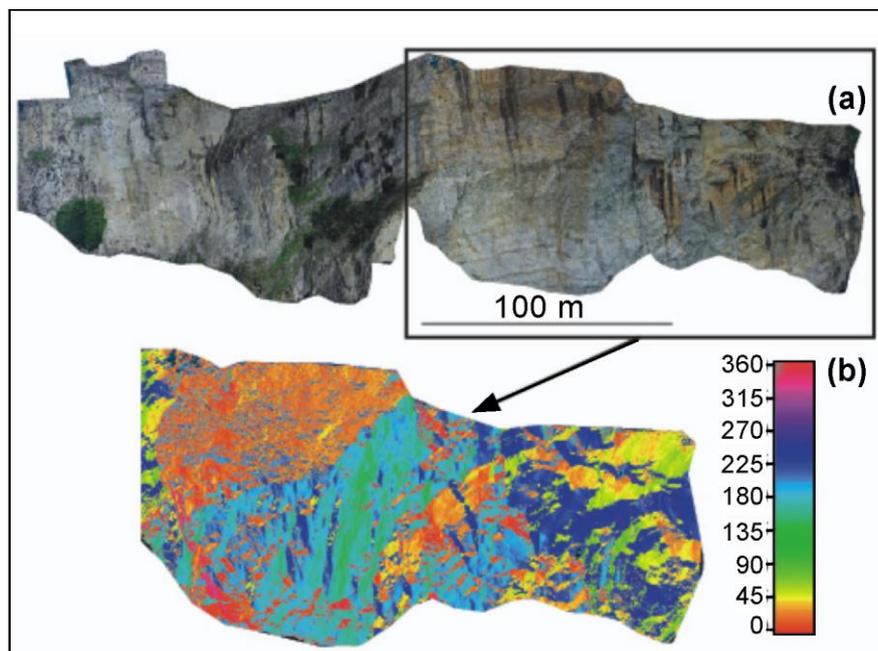
Figure 2. San Leo slope: (a) 3D point cloud extracted from UAV survey; (b) CloudCompare output; color scale represents slope face dip directions.

The results presented incorporate the use of UAV photogrammetry for rock mass classification using Q-slope. Due to safety risks associated with rock fall and limited physical access to the physical, UAV surveys have been carried to improve the amount and quality of data available for the analysis. The post processing of UAV photographs allowed for the creation of 3D photogrammetric models representing the slopes under study. Figures 2 and 3 show the 3D models of the San Leo slope and benches in the open pit mine, respectively.

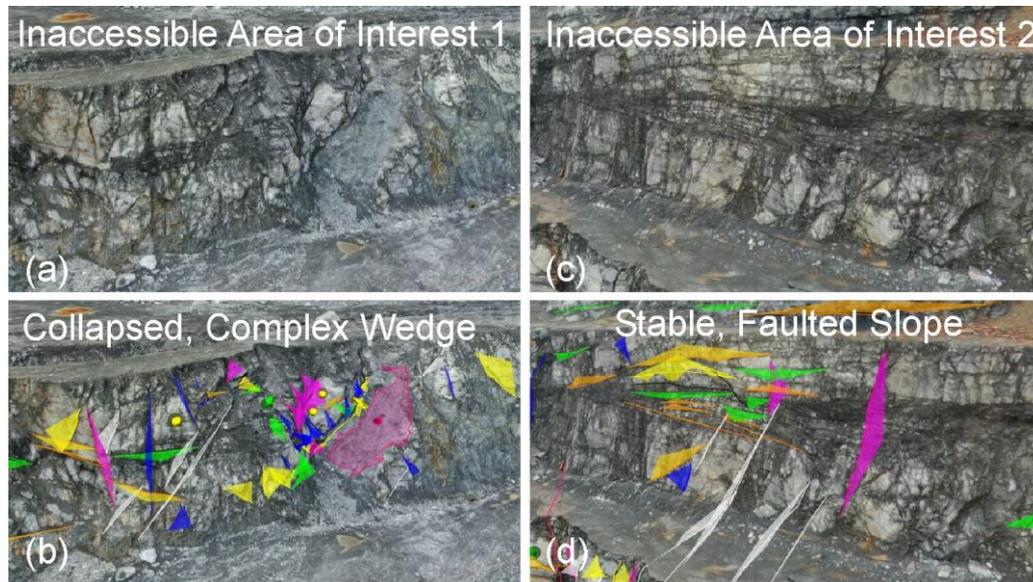
Figure 3. Open pit mine benches in the Caribbean. (a) & (b): Area 1 showing a local, complex wedge failure controlled by 3 discontinuity sets; (c) & (d): Area 2 showing stable slope with 2 discontinuity sets and random joints.

The open pit slopes (figure 3) are hosted in carbonaceous sediments comprising mudstones and sandstones, interbedded with various tuffs. The strata is generally sub-horizontal although it has been

Area 1 in the open pit mine is a failed slope (localized wedge), with a height of 10 m and a pre-failure slope angle of 56 degrees. Area 2 is a stable slope, 11 m high with a slope angle of 57 degrees. Mapping of geological structures using UAV photogrammetry models highlighted the presence of three main joint sets for Area 1 and two main joint sets (plus random joints) for Area 2 (figure 5 and Table 1). The parameters for estimating Q-slope (Table 1) were obtained from logging nearby boreholes. RQD was estimated to be 70% on average in both the slopes. This was confirmed with UAV photogrammetry focusing on open fractures in the slope.

Area 1 is characterized by a complex wedge failure where the joint sets (Set A and B, Table 1) are characterized by a smooth, undulating joint surfaces. The Set B has clayey infilling, while infill in Set A comprises sandy particles and rock fragments. Area 2 is stable and has similar joint characteristics to Set A in Area 1. O-factors have been described based on the orientation of the discontinuity sets relative to the slope.

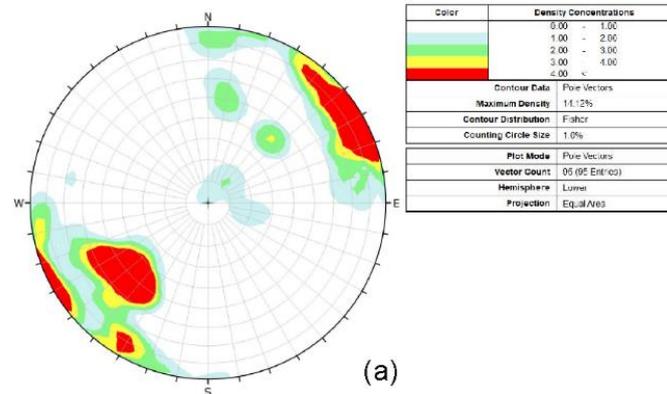
Figure 4. Stereonet representing the discontinuity sets in San Leo (note: bedding not shown for clarity).

Regarding the San Leo case study, the natural slope, about 80 m high, is sub-vertical and characterized by a large slope (planar) failure that in 2014 led to a subsequent rock fall. The structural/geomechanical analysis highlighted the presence of three discontinuity sets (Fig. 4, which excludes bedding). The other parameters useful for the estimation of Q-slope can be summarized as it follows. The RQD is equal to 100%, testify a good quality of the rock mass. The main discontinuity set involved in the instability of the slope (Set A, Table 1) is characterized by a clean, irregular, undulating surface (joint roughness - J_r of 3). The environmental and geological conditions are typical of a wet environment with a J_{wice} of 0.7. Considering the very unfavourable orientation of Set A (causing failure if unsupported), with an orientation factor of 0.25, the calculated Q-slope is equal to 5.83.

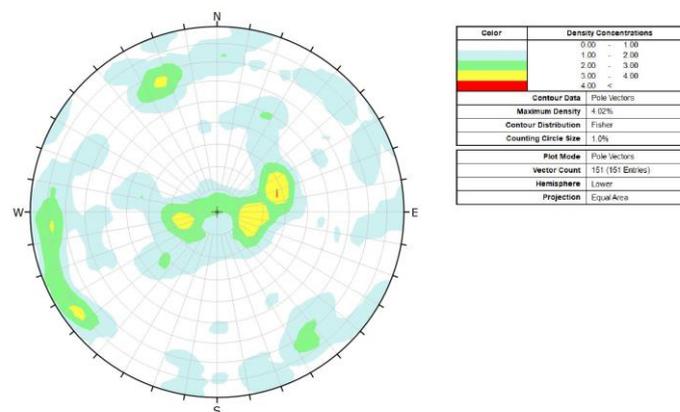
Figure 5. Stereonet representing the discontinuity sets in the open pit mine, inclusive of Area 1 and 2.

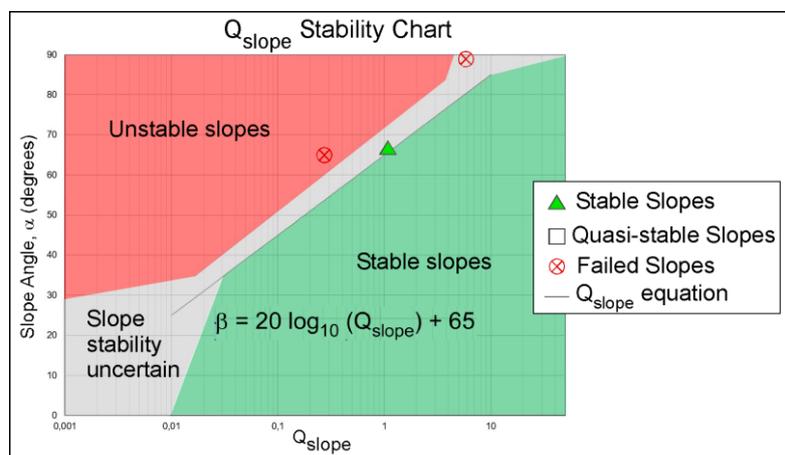
Figure 6. Q-slope stability chart with Italian and Caribbean case studies using UAV photogrammetry

UAV photogrammetry and Q-slope were applied to natural and engineered slopes for the case studies in hazardous areas in Italy and in the Caribbean. The results shown in figure 6 are in agreement with previous Q-slope assessments that were completed, on foot, in the field.
