Geomatics, Natural Hazards and Risk

The use of an unmanned aerial vehicle for fracture mapping within a marble quarry (Carrara, Italy): photogrammetry and discrete fracture network modelling

Department of Environment, Earth and Physical Sciences and Centre of GeoTechnologies CGT, University of Siena, San Giovanni Valdarno, Italy

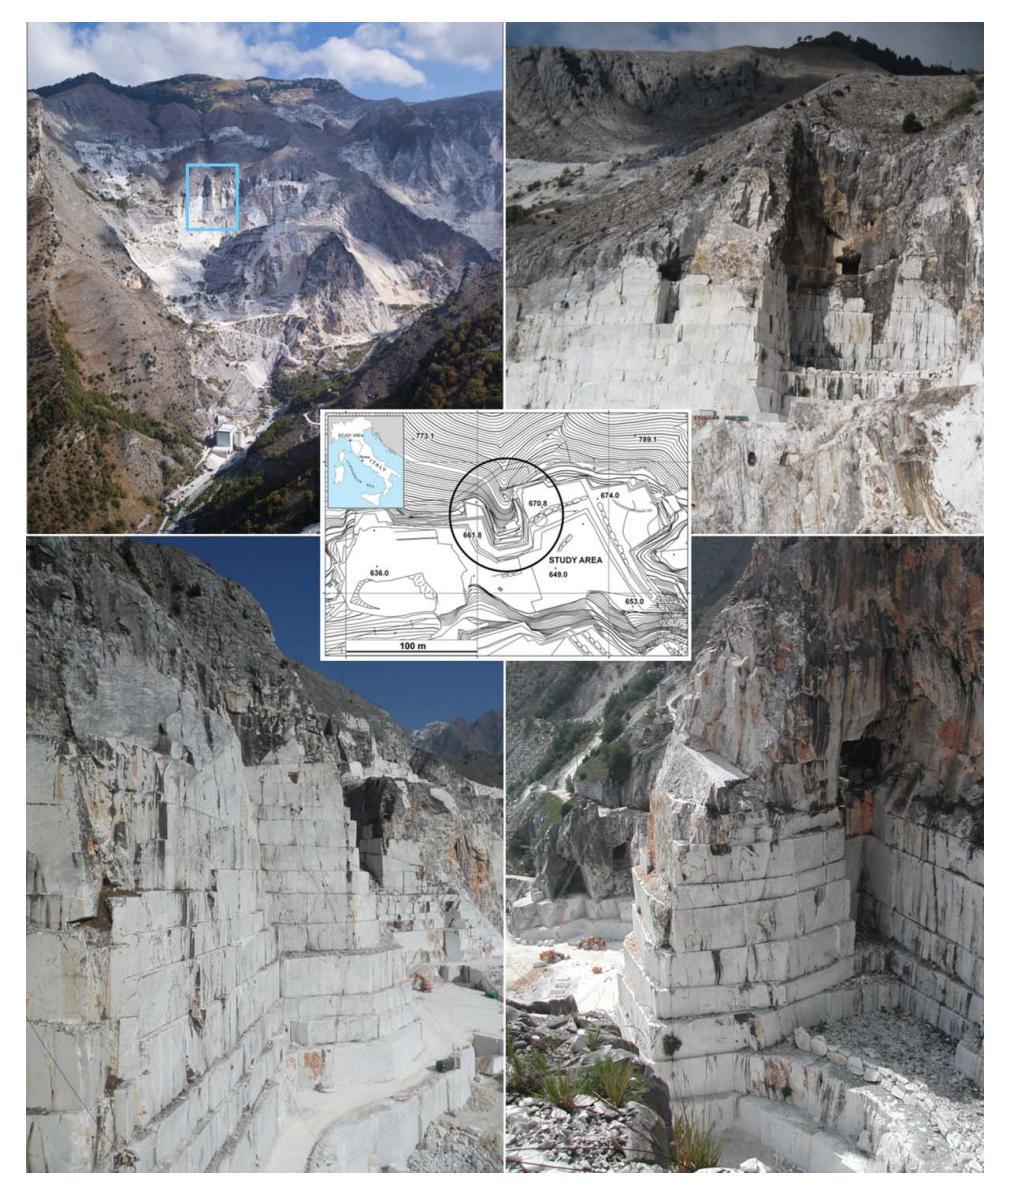
Figure 1. Study area. Topography of the site (in the centre, reproduced with permission from Springer published paper Salvini et al. 2014); black circle indicates the marble buttress; inset map shows the location of the study area. Panoramic view of the quarry, with the investigated buttress highlighted by a rectangle (upper left); southern side of the buttress (upper right), western side of the buttress (lower left) and eastern side of the buttress (lower right).

were subsequently carried out with the aim of ensuring safety, and a marble buttress accessible from three sides was emplaced (Figure 1). Due to the ongoing quarrying activity the buttress is now about 150 m high, 30 m wide and 40 m thick.

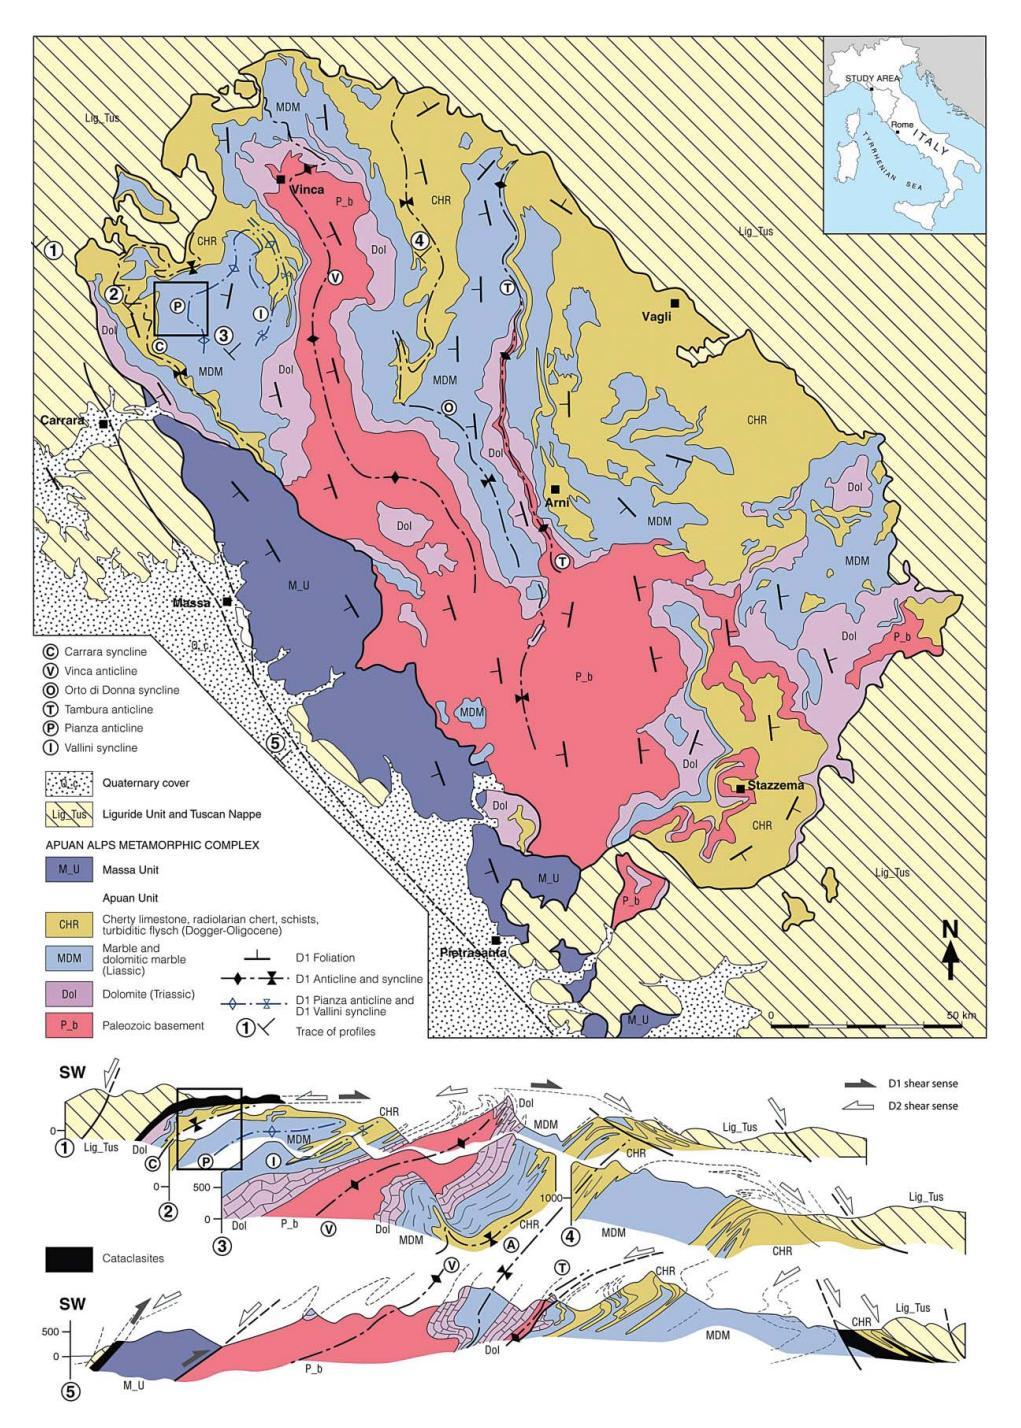
Figure 2. Geological sketch map of the Apuan Alps. The black rectangle indicates the location of the quarry. This figure is reprinted with permission from Elsevier published paper Salvini et al. 2015.

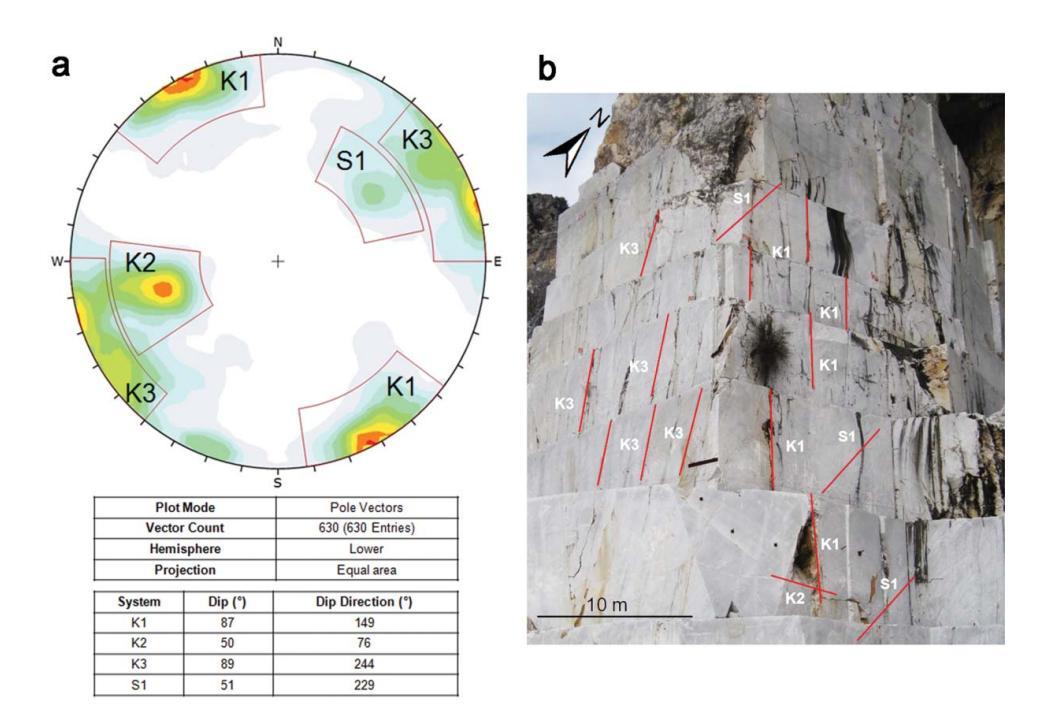
Figure 3. Joint systems. (a) Pole plots and mean attitudes of joint systems from engineering geological, DTP and TLS surveys. Data are shown in stereographic projection using the Schmidt equal-area method. (b) Examples of K1, K2, and K3 joint systems and S1 foliation in the buttress. This figure is reprinted with permission from Elsevier published paper Salvini et al. 2015.

An engineering geological survey was carried out to characterize the geomechanical properties of discontinuities. Data were collected in accessible areas using traditional scan-line mapping techniques whereby all the discontinuities that intersect a defined scan line are recorded. About 100 discontinuities longer than 10 m were identified in seven scan lines. Collected data were compared with those of Profeti and Cella (2010) for the same area and integrated with DTP and TLS data from inaccessible zones, as described in Francioni et al. (2015). The attitude of 301 joints was calculated from TLS and an additional 236 discontinuities were manually measured from the photointerpretation of UAV imagery (Francioni et al. 2015). Data processing revealed the following four sets of discontinuities (named K1, K2, K3 and S1 in accordance with Profeti & Cella 2010) describing the current state of the buttress (Figure 3): S1 (foliation), SW dipping with average dip of about 50°, corresponding to Sp of Carmignani et al. (2002); K1, SE dipping, subvertical, corresponding to J2 of Carmignani et al. (2002); and K3, SW dipping, subvertical, corresponding to J3 of Carmignani et al. (2002).

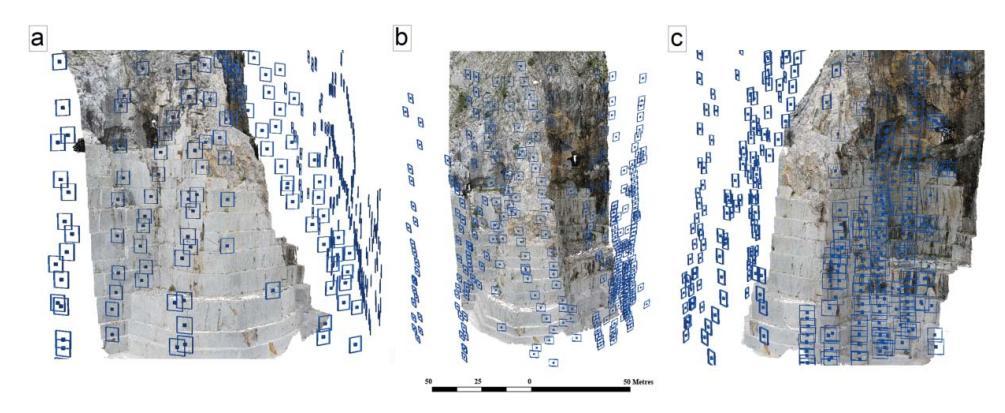
Figure 4. Panoramic views of the camera positions: (a) west side of the buttress; (b) south side of the buttress; (c) east side of the buttress.

Five vertical flights with 80% overlap and 40% sidelap ensured coverage of the entire area; the photos were taken from an average distance of 30 m from the slope surface (Figure 4), yielding an estimated Ground Sample Distance of about 1 cm.

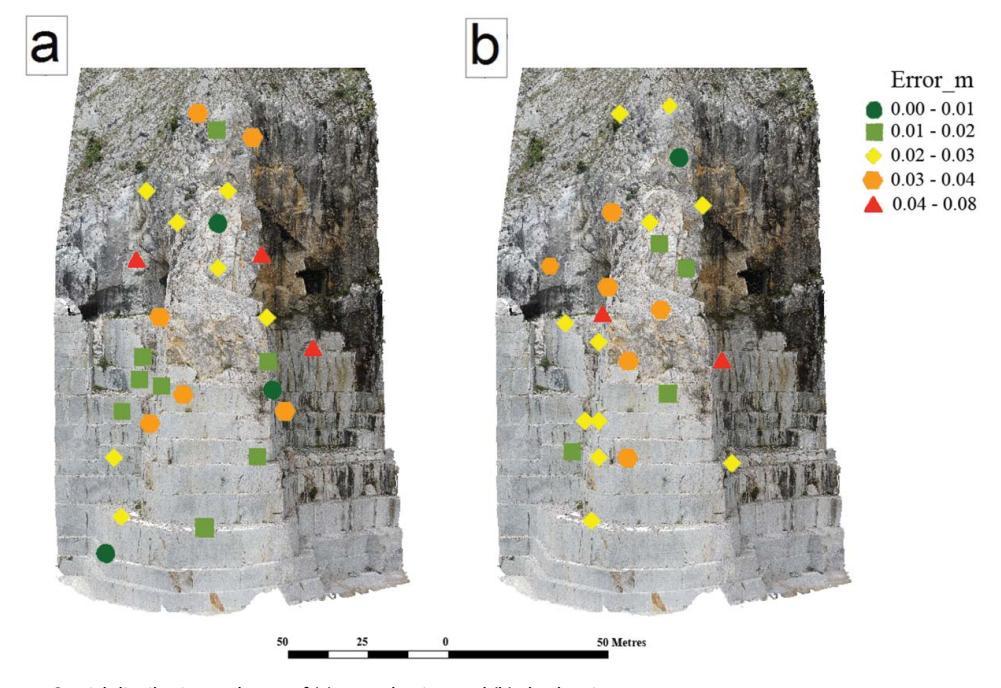
Figure 5. Spatial distribution and error of (a) control points and (b) check points.

PhotoScan's *optimize* tool (Agisoft 2016) was used to adjust the estimated camera positions and to remove possible non-linear deformations, minimizing the errors due to reprojection and misalignment of the photos. At the end of the process the estimated root mean square error (RMSE) of GCPs was 0.029 m, and that of the check points was 0.033 m.

In order to assess the reliability of the obtained RMSEs, the selection and number of control and check points on the buttress were varied. Table 3 shows the results of three tests completed by varying the number of control and check points. Considering 54 GCPs, when the number of control and check points is varied from 29 to 16 and from 25 to 38, respectively, the resulting RMSE does not change (only 1 mm for check points). In order to validate the RMSE achieved with 29 control points, the accuracy of 10 check points was determined: 0.025 m (Table 3). From this it follows that the availability of a large number of spatially well-distributed GCPs allows accuracy assessment thanks to the numerous check points and the correct orientation of images. Figure 5 shows the spatial distribution and error of GCPs in the final configuration (29 control points and 25 check points).

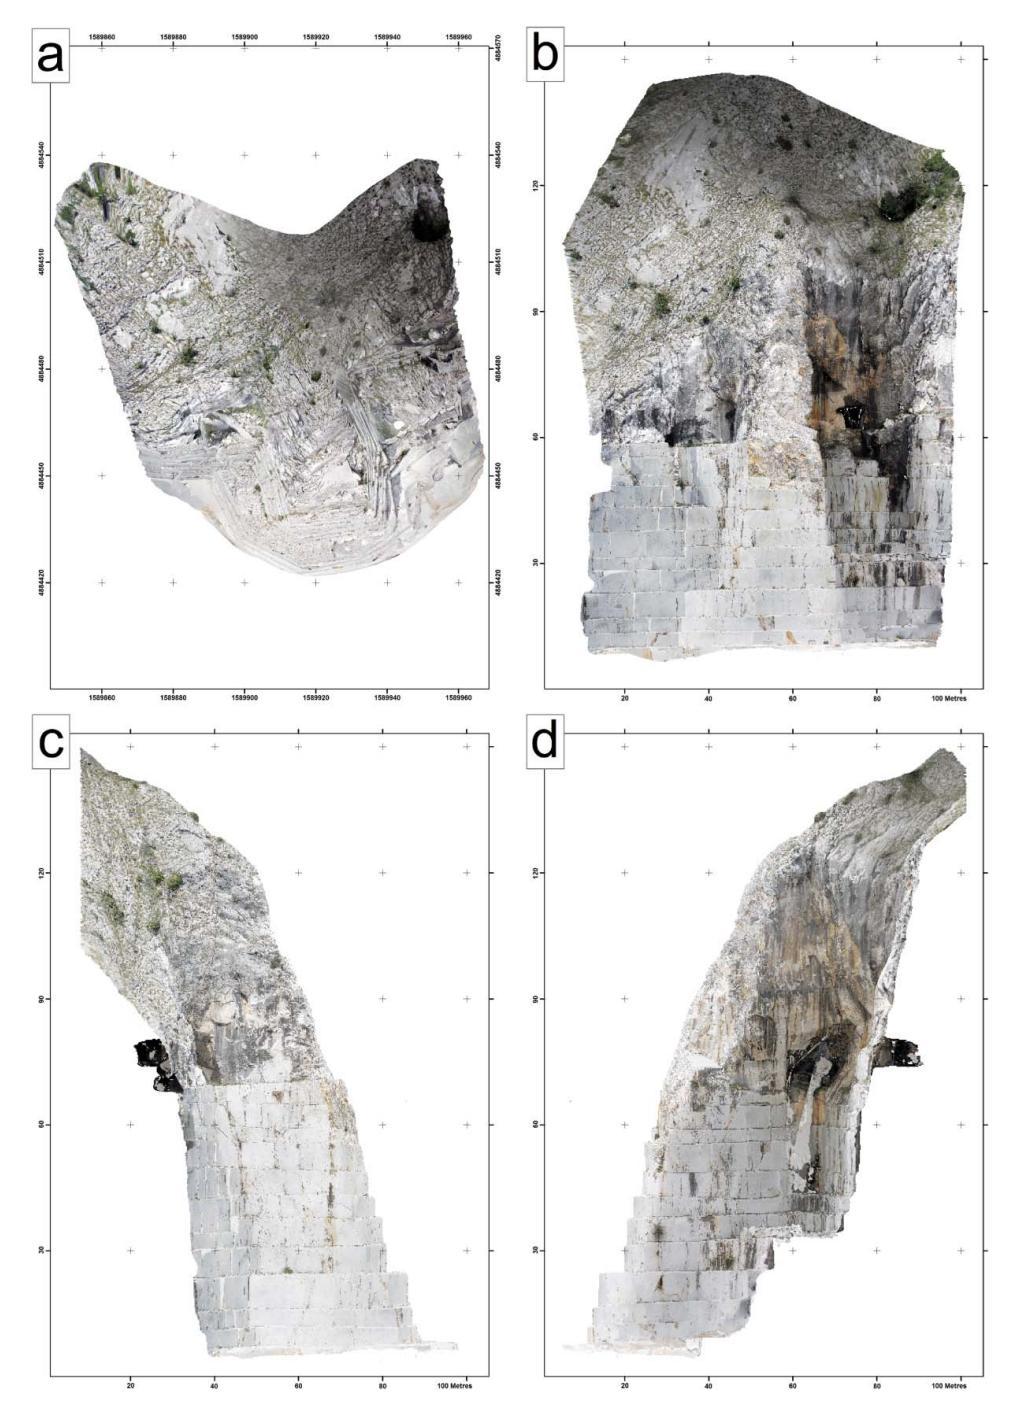
Figure 6. Orthophotos: (a) top view of the buttress, (b) south side of the buttress, (c) west side of the buttress, (d) east side of the buttress.

(i.e. lens distortions), camera tilt and topographic relief displacement. Unlike an uncorrected aerial photograph with a perspective projection, an orthophoto is geometrically corrected ('orthorectified') and can be used to measure true distances since it is 'scale-corrected.' Four different planes of reference, one for each side of the buttress (eastern, southern and western) and an overhead view, were selected for measurements. The resulting orthophotos with a spatial resolution of 1 cm/pixel were exported in the local coordinate system; only the top view was projected into the Italian National Gauss–Boaga system (Figure 6).

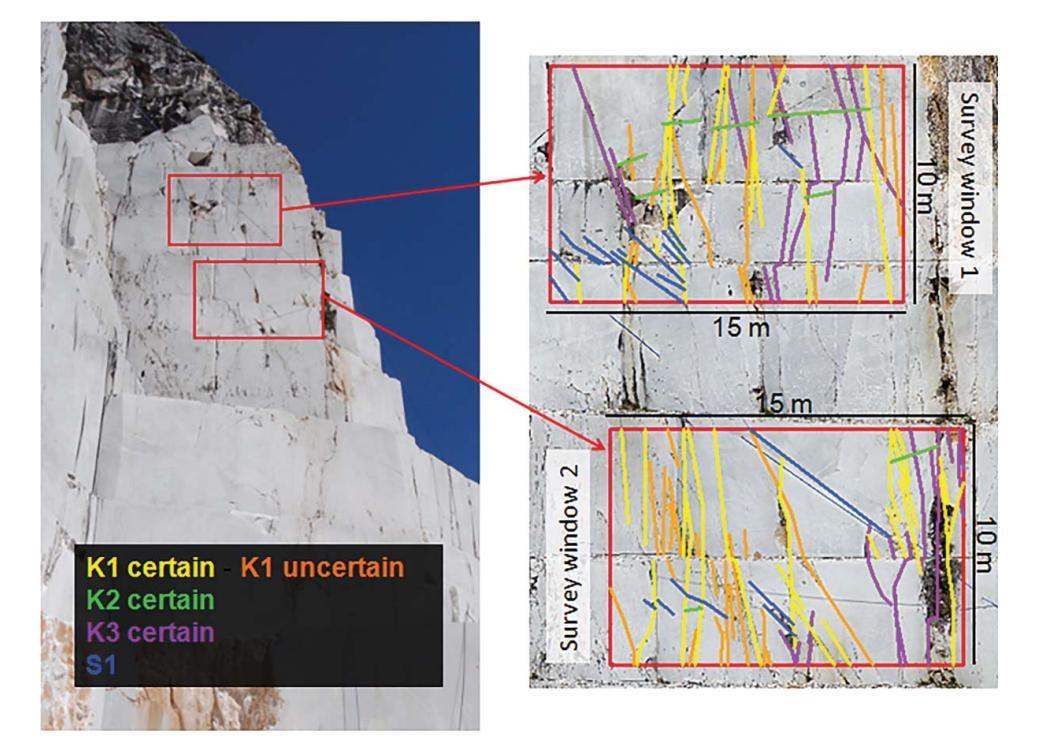
Figure 7. Survey windows 1 and 2 used to map discontinuity sets K1, K2 and K3, as well as foliation S1, on the western side of the buttress.

By combining 2D and 3D views with data collected during *in situ* surveys, discontinuities on all three sides of the marble buttress were identified with a high degree of certainty. Despite efforts to minimize uncertainty, discontinuities with uncertain attitude were also mapped because some highly dipping sets (e.g. K1 and K3) produce similar line traces on the buttress surface. The deterministic maps of discontinuities (with length greater than 2 m) are shown in Figures 7 and 8.

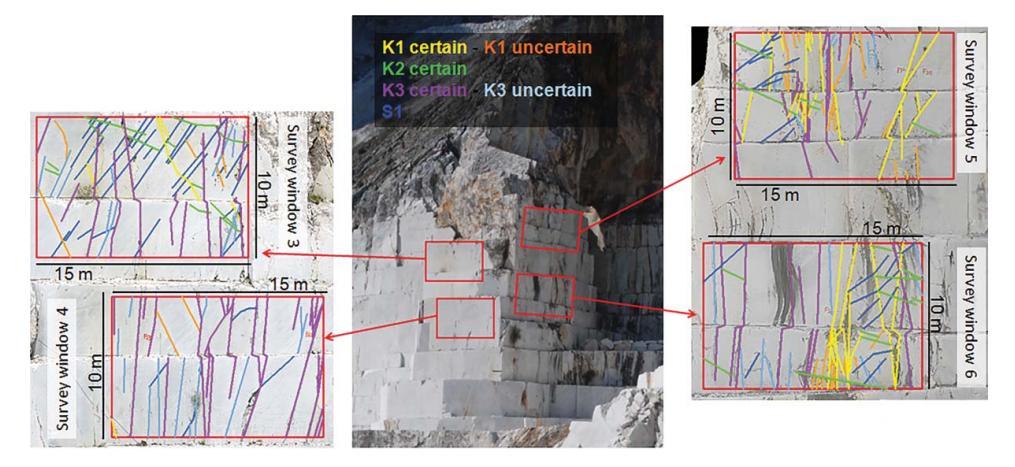
Figure 8. Survey windows 3–6 used to map discontinuity sets K1, K2 and K3, as well as foliation S1, on the southern and eastern sides of the buttress.

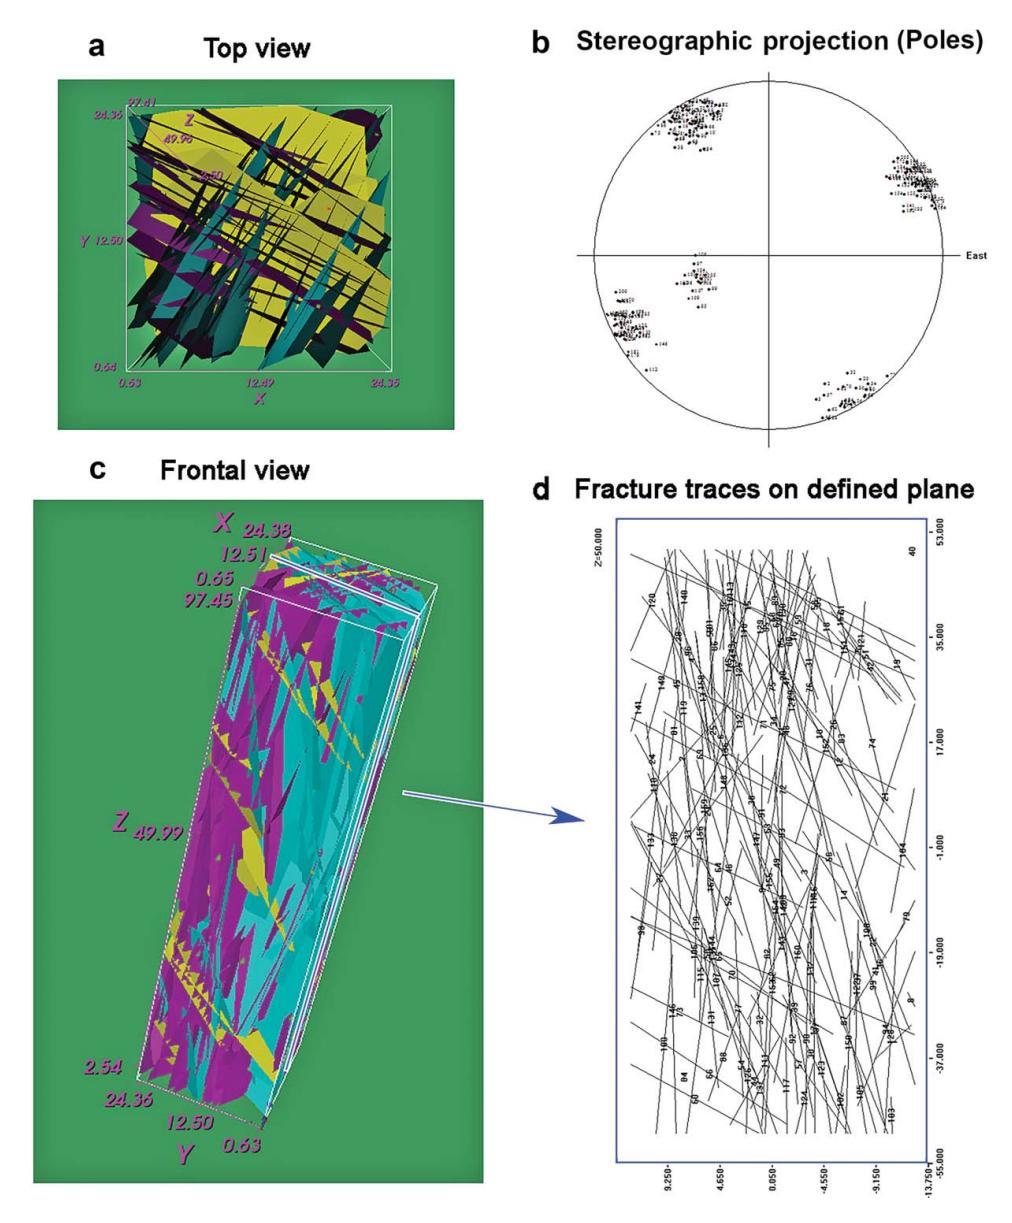
Figure 9. Generation of a DFN model for the marble buttress using FracSim3D. K1, K2 and K3 joint sets included.

The S1 foliation was not included in the shown model because it does not represent a real plane of discontinuity in the studied quarry. Nevertheless, it is a plane of weakness that could affect the stability of the buttress and will be the subject of future research.

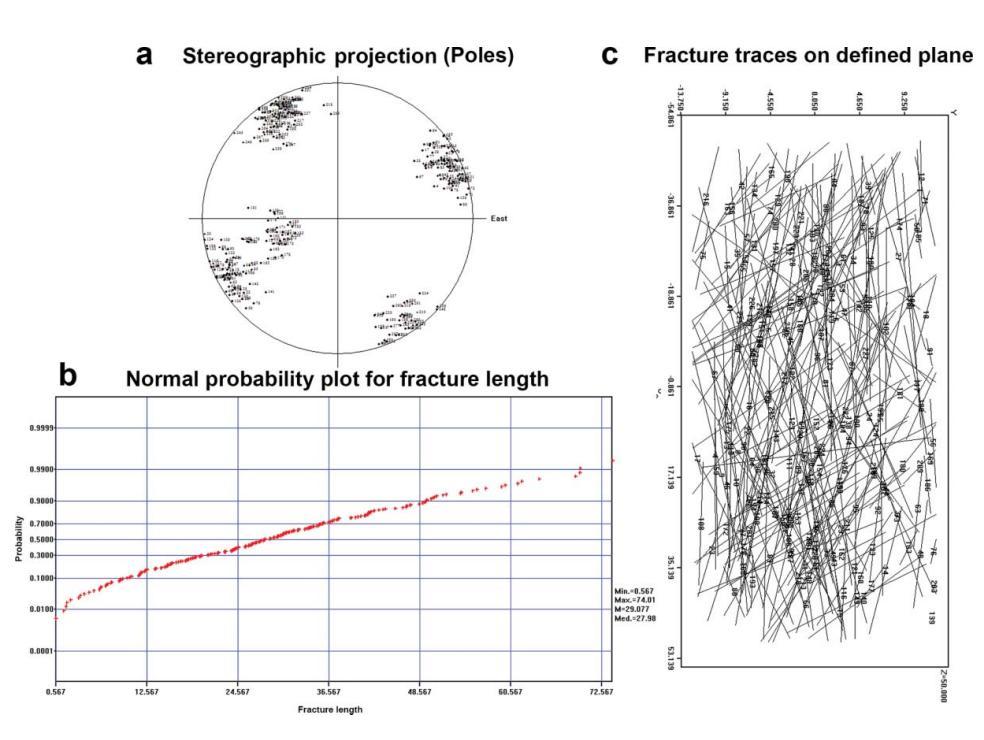
Figure 10. Generation of a DFN model for the marble buttress using FracSim3D with P_{10} certain values. K1, K2 and K3 joint sets included. The location of the defined plane is the same as that of Figure 9.

Several models can be created to assess the influence of uncertainty on the SRM model and improve the reliability of results. This is particularly important because several trial runs can be completed and analyzed in order to obtain reliable results for a stochastic representation of a natural discontinuity network. For example, Figures 10 and 11 show 2D representations (including stereographic projection and normal probability plots for fracture lengths) of two DFN models generated using respectively certain and certain+uncertain P_{10} values (as average among all the six mapped windows).

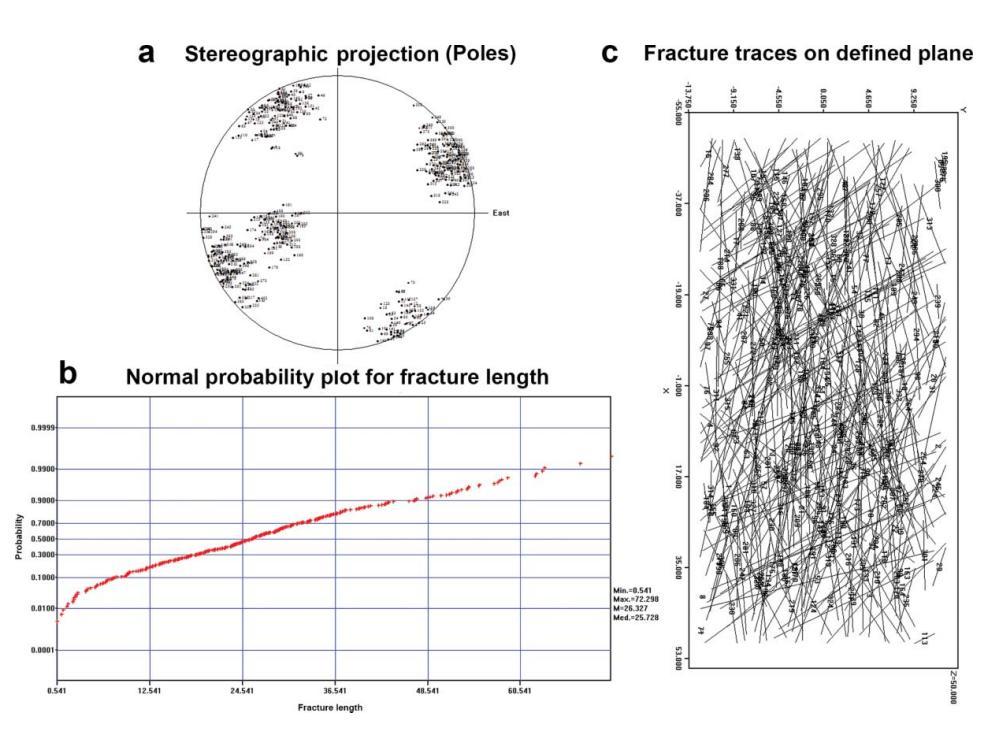
Figure 11. Generation of a DFN model for the marble buttress using FracSim3D with P_{10} certain+uncertain values. K1, K2 and K3 joint sets included. The location of the defined plane is the same as that of Figure 9.

In addition, both certain and uncertain joint attitudes were discerned in this work. This was done because on a flat surface like a quarry wall face it is difficult to correctly interpret the set to which a discontinuity belongs, an important point requiring further studies in the context of DFN model calibration and validation. Although the geometric parameters required to build a DFN (fracture location, size, shape, orientation, density, flow property and number of sets) can all be derived deterministically through photointerpretation, additional statistical input is important for generating the discontinuity sets. The presence of joints with an uncertain attitude results in a model with a higher number of discontinuities showed, as an example, by comparing Figures 10 and 11. In fact, the DFN model obtained using $P_{certain+uncertain}$ values, resulted in a 32% increase of the number of

discontinuities, from 306 to 404 joints. On the other hand, uncertain discontinuities may not be representative of specific sets but of random fractures. The key aspect in this case is that the amount of data collected thanks to the adopted UAV-based approach can possibly lead to the development of a large number of different DFN models to be used for stability analysis purposes, which are more likely to satisfy the statistical criteria.
